## CASE STUDY

# San Lorenzo Valley Water District (SLVWD) is still recovering from the CZU Complex fire that led to burned plastic water pipes.

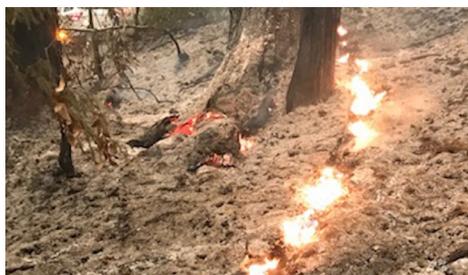
*High-density polyethylene (HDPE) pipe burning in the CZU Lightning Complex Fire.<sup>4</sup>*

In 2021, more than 900 homes were destroyed in the CZU Lightning Complex Fire that tore through 86 thousand acres in the Santa Cruz Mountains. The district lost 4.5 million gallons of water after a seven-mile-long high-density polyethylene (HDPE) pipe melted from the intense heat. To have enough water to fight this fire, “Officials with the SLV Water District had to refocus water flow so firefighters battling the fire would have access to water.”<sup>1</sup> The district lost 100% of its raw water intake structures, including all three water tanks, which store millions of gallons of water. The seven miles of HDPE piping was also destroyed, after it had melted.

“The District lost seven miles of high-density polyethylene (HDPE) pipe in the CZU fire. During the fire, Rogers said, “All the pipe melted below the storage tanks, and all five million gallons went right out onto the road and down into the creek in a 12-hour period.” And while the storage tanks are made of steel and survived the fire, the pipe acted like a chimney, so the toxic smoke and soot pulled up into the melting pipe and came out in the tanks, coating them inside with residual HDPE.”
