Ductile Iron Pipe
Research Association

TAPPING

Direct Tapping of 6-Inch Pressure Class 350 Ductile Iron Pipe

by Richard W. Bonds, P.E.

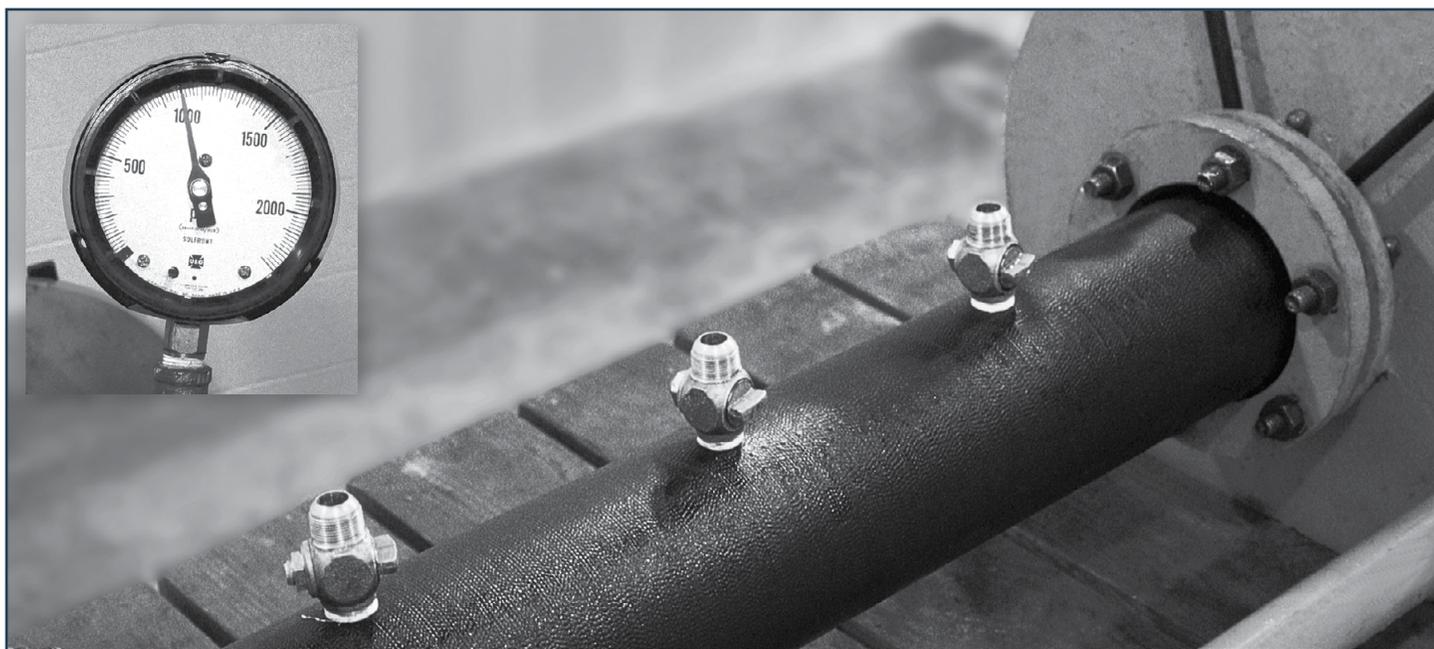
DIPRA’s direct tapping tests were conducted on 4-foot Ductile Iron Pipe specimens 6 inches in diameter. Tests involved three 3/4-inch taps on one specimen and three 1-inch taps on the other specimen as shown here. The initial internal water pressure of 70 psi was gradually increased to 1,000 psi (inset photo) in an attempt to cause failure.

Two 6-inch diameter, Pressure Class 350, cement-mortar lined Ductile Iron Pipe specimens were used for these tests. A concerted effort was required to procure specimens with a wall thickness below the nominal specified in ANSI/AWWA C151/A21.51, “Ductile-Iron Pipe, Centrifugally Cast, For Water.” Each specimen was 4 feet long, sealed with mechanical joint end caps, and secured in a test press. The direct tapping was performed with a Mueller B-100 drilling and tapping machine. Detailed procedures for each testing category follow.

The initial internal water pressure of 70 psi was increased to 100 psi after the first inspection. Internal pressure was then increased slowly at 100 psi increments to 500 psi under constant observation and inspection. At that point the pressure was increased to 1,000 psi in an attempt to cause failure.

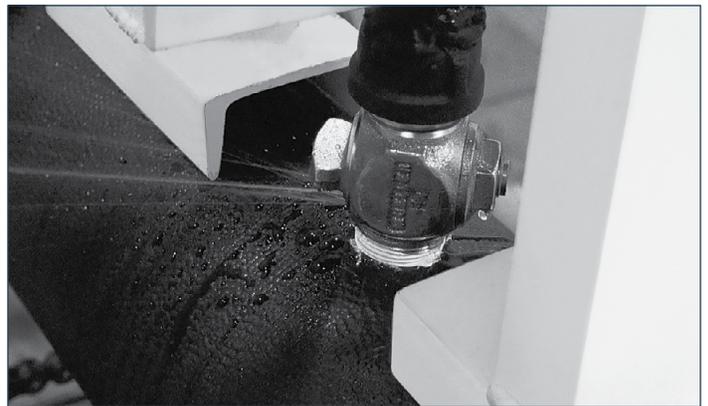
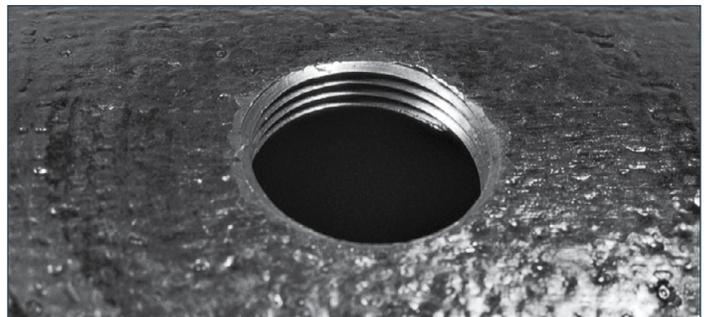
Forces exerted during pull-out tests, when sufficient, resulted in failure of the corporation stop, not the Ductile Iron Pipe or threads. The top photo shows leakage at the plug key of the corporation stop. Ultimate failure occurred to the corporation stop's threaded connection for the service line. The undamaged Ductile Iron Pipe and threads are shown in the photo below.

The pull-out tests were conducted to evaluate the strength and integrity of the corporation stops' threaded connection to the pipe. An average pulling force of 3,028 lbf initiated leakage around the closed plug key of the corporation stops (no leakage was observed at the threaded connection to the pipe). Actual failure occurred at an average of 6,969 lbf of pulling force. These failures occurred to the corporation stops' threaded connection for the service line, not the threaded connection to the pipe. These tests included only 3/4-inch corporations.

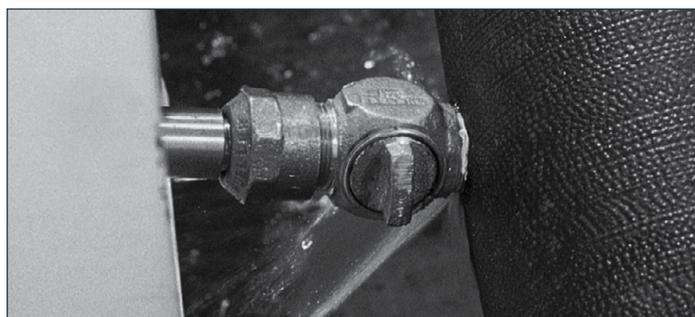
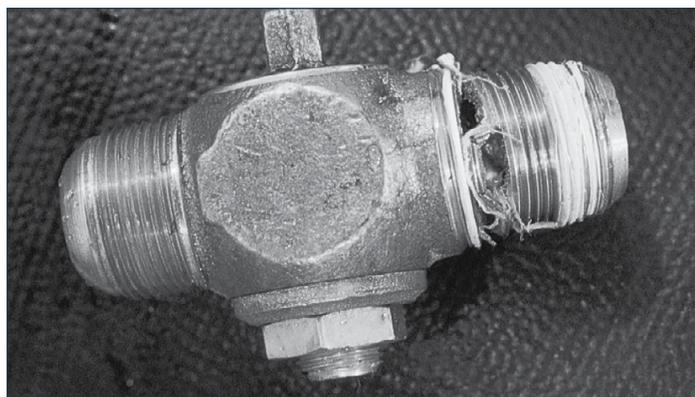
As was the case in the pull-out tests, sufficient cantilever forces damaged the corporation stop, causing the leakage seen in the photo above (top). Damage to the corporation stop is shown above (bottom).

Similar to the pull-out tests, the cantilever load testing was conducted to evaluate the strength of the direct tap connection to the pipe. The three corporation stops subjected to the cantilever loading began to leak at an average bending moment of 3,125 in-lbf. There was no leakage at the threaded connection to the pipe. Failure of the corporation stops required an average bending moment of 4,784 in-lbf and occurred at the two or three exposed threads just outside of the threaded connection to the pipe. These tests included only 3/4-inch corporations.

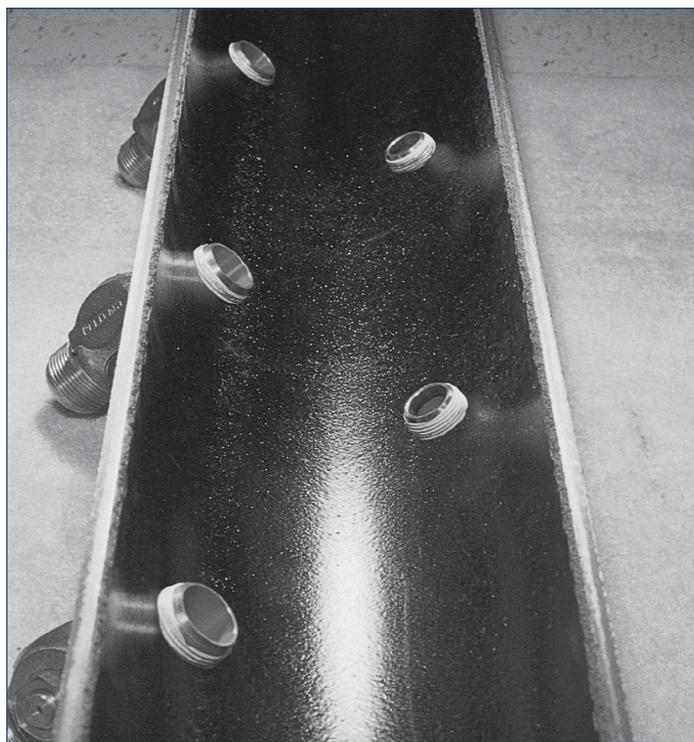
This cutaway view of the inside of a tapped Ductile Iron Pipe clearly shows that the corporation stops do not damage the cement-mortar lining of the pipe.

5. Direct tapping does not harm the cement-mortar lining. The lining remains intact and spalling does not occur.
6. Pull-out and cantilever forces, when sufficient, result in failure to the corporation stop, not the pipe or threads. This was also the case in direct tapping tests DIPRA conducted in 1976 and 1987.
