TECHNICAL INFORMATION - EFFLORESCENCE SITE PRACTICE

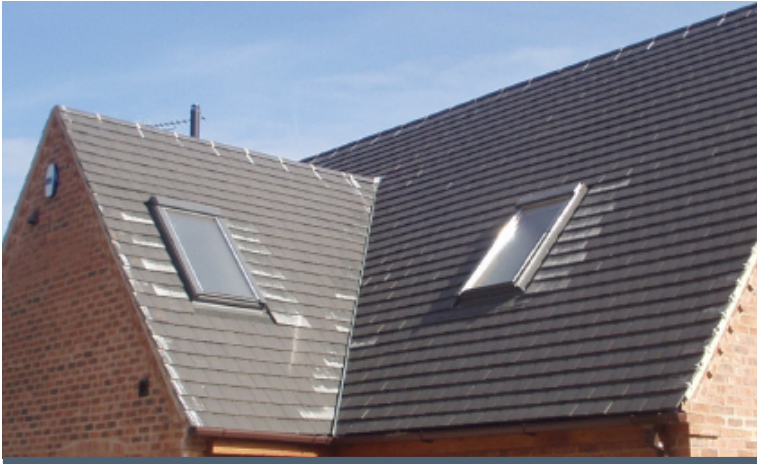
Efflorescence is the appearance of salt deposits on the surface of roof tiles. They can derive from the tile body, mortar, or contamination from other materials.

Visible as a harmless deposit of soluble material on the surface of tiles, its texture may vary from light and fluffy to hard and glassy depending upon its composition. The deposits consist of naturally occurring soluble salts which vary considerably throughout the country.

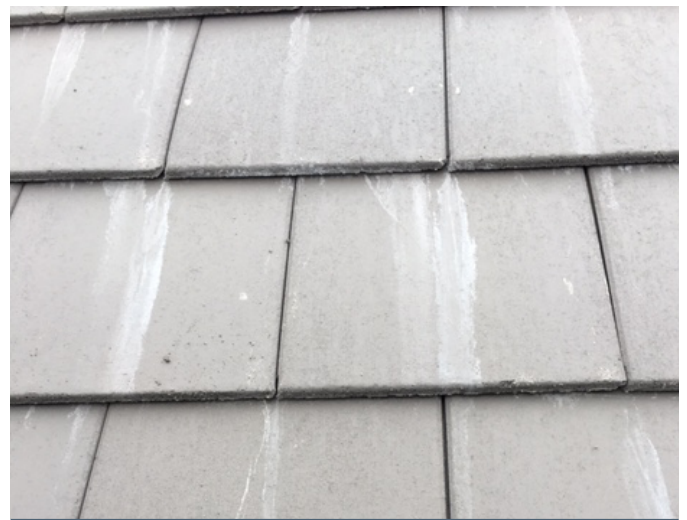
The natural weathering process will reduce the effects of efflorescence on tiles. It is difficult to ascertain how long the effects last and this depends on the amount of deposit, local weather, and atmospheric conditions. As rain water is slightly acidic it dissolves the deposits on the roof tile surface therefore they will disappear over time.
