Bradken Duaplate DX Plate for Vibe Feeder

Location	Pilbara Region, WA, Australia
Asset	Vibrating Pan Feeder
Conditions	>32mm Sized Iron Ore
Solution	Bradken Duaplate DX

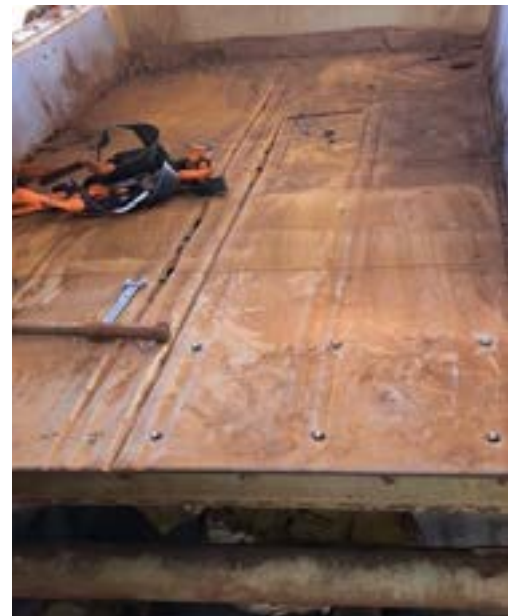
A customer in the Pilbara Region of Western Australia, was operating four Vibrating Pan Feeders processing secondary crushed iron ore. These vibrating feeders were lined in 500BHN Abrasion Resistant Steel Plates as specified by the Original Equipment Manufacturer (OEM). The OEM liner package had large gaps in the direction of material flow, which resulted in extreme washout limiting the operational life of the liners to 13 weeks. These liners also weighed more than 70kg and did not incorporate any lifting solutions, creating safety issues during install and removal on-site.

OEM Vibrating Pan Feeder liner with extreme washout

Bradken reverse engineered the OEM liner package and revised the liner material to utilise our new high performance Duaplate DX weld overlay material. The new liner package was supplied with the same total thickness as the OEM liner package to maintain the same overall liner mass. The new design consolidated the liners along each row into a single liner to eliminate the washout problem by removing the gaps between the liners. The new liners also incorporated reusable lifting points that allowed the liners to be installed and removed safely using an overhead crane.

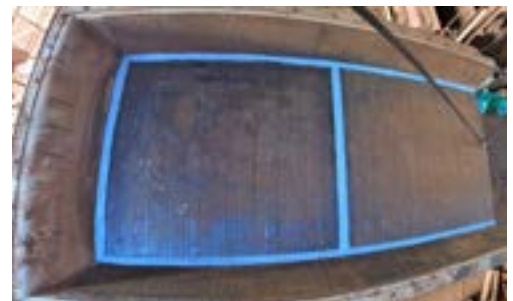
Bradken Duaplate DX 8/8 liner installed

The customer trailed the new Duaplate DX 8/8 liner package in one of the feeders and after 13 weeks, the solution was performing so well, the customer committed to changing all four feeders to the new Bradken liner package. After completing their operational campaigns, the Duaplate DX 8/8 liners met the customer's expectation of 48 weeks of operational life. This allowed the liner package to be changed during the scheduled workshop refurbishment cycle of the Vibrating Feeders, completely eliminating liner change-outs insitu onsite.
