# Vulcabrix® Ceramic Liners

<b>Location</b>	Arizona, USA
<b>Platform</b>	Tripper Transfer Chute
<b>Conditions</b>	Coarse Ore/ Sliding Abrasion / Impact
<b>Solution</b>	Redesigned Tripper Transfer Chute lined with Vulcabrix Ceramic Liners, Duablock and Duacast Billets

BK-Sales & Marketing-Global-Record-Case Study-MP-Vulcabrix AZ-Coarse Ore Tripper -English

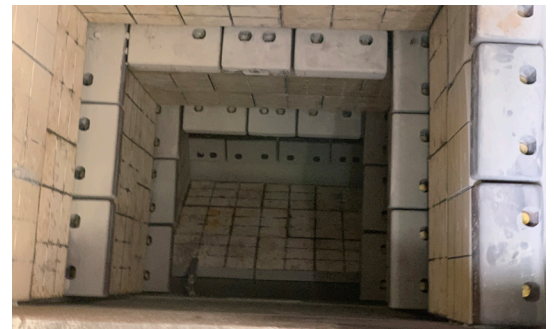
Vulcabrix liners, Duracast and Duablock Billet liners in the tripper pant legs

The discharge was modified so that direct impact on the bin walls below the tripper was eliminated, resulting in significant long-term savings, and novel sealing belt system was added to seal the bin openings to reduce dust generation. The solution was installed in June 2019 including strategically placed Vulcabrix, Duracast and Duaplate liners.

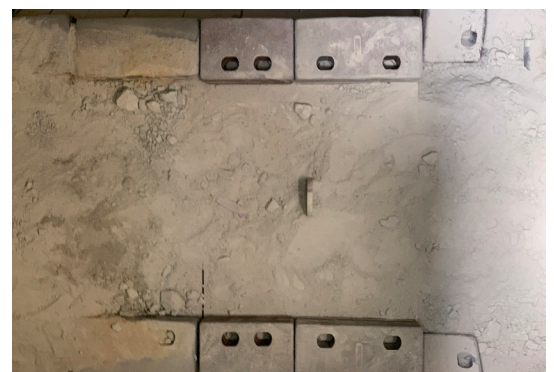
Duablock Liners used in higher wear areas
