Reference Number	Bulletin 04 - 2019
Affected Product	All Caterpillar AD30, R1700 & R1700G machines
Risks Identified	Potential for incorrect application of 216-8022 lift tooling
Release Date	22 October 2019

Caterpillar 216-8022 lifting tool – potential for misapplication

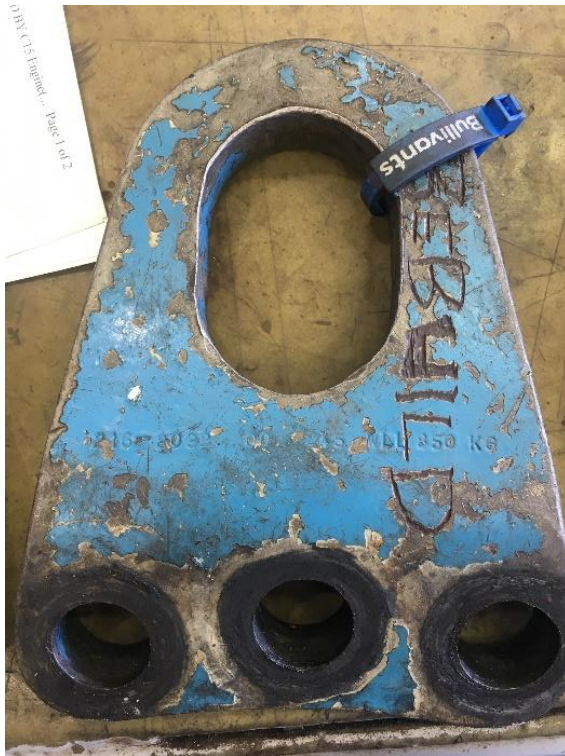
Figure 1 - 216-8022 Tool

The Caterpillar 216-8022 lifting tool forms part of the 190-5213 or 472-8796 tool groups. The 216-8022 tool is used for lifting purposes during component removal and installation on listed product.

To allow attachment of lifting equipment and subsequent handling, a single 216-8022 tool can be temporarily bolted to final drive and brake groups, or a pair of the 216-8022 tools can be temporarily bolted to complete axle assemblies via both end flanges.

1. Locate all 216-8022 tools held in parts stock warehouses and tool stores, workshops and service vehicles.
2. Identify each 216-8022 tool's capacity either by the stamped WLL or part number markings.

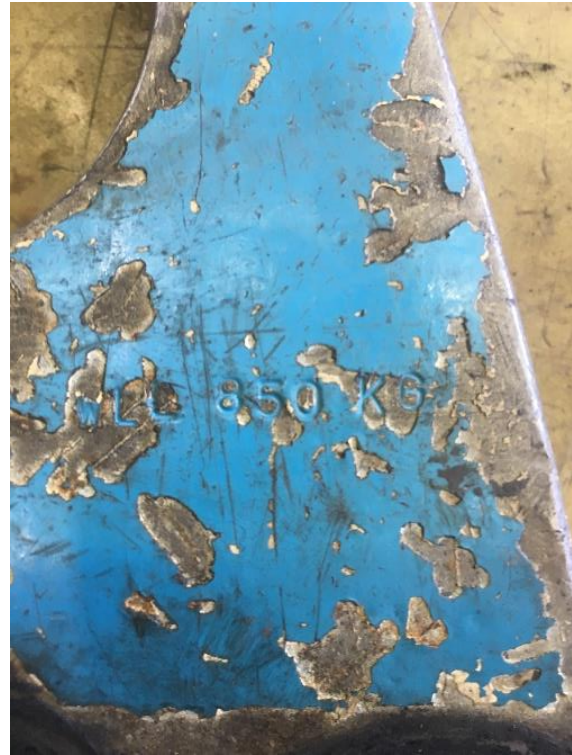
Figure 2 - WLL marking 850 kg

- Early versions of the 216-8022 tool [identified by _00 after the part number] have a working load limit [WLL] of 850 kg. The 850 kg WLL is not adequate for lifting/handling the complete axle assemblies on the Affected Products.
- While the 850 kg WLL of each individual tool provides a combined WLL of 1700 kg, this is lower than the mass of fixed front axles [approximate mass 2330 kg] or oscillating rear axles [approximate mass 2515 kg] on R1700 and R1700G machines.
- The 850 kg WLL is also lower than the mass of fixed front axles [approximate mass 2330 kg] or rear axles [approximate mass 2515 kg] on AD30 machines.
- The 850 kg WLL is adequate for lifting the final drive and brake assembly [approximate mass 480 kg] when separated from the axle assemblies on AD30, R1700 and R1700G machines.

3. If the tool is marked with a WLL of 850 kg, or is marked 216-8022_00, then it is recommended the tool be immediately withdrawn from service and scrapped to eliminate the potential for misuse to lift a complete axle assembly, as current service procedures do not identify this potential discrepancy with the lift capacity of the tooling.

4. If the part number revision or WLL is indistinct, the version of the tool can be identified by measuring the section thickness of the steel. The 216-8022_00 has a plate section thickness of 20 mm, and the later 216-8022_01 has a plate thickness of 25 mm. If the plate section thickness is 20 mm, then the tool is recommended to be scrapped as per the above point.
