GEOSCAPES Reference: # 200723_MOD4_LET_RFI01

Re. **Westlink Stage 1 (SSD-9138102) – Northern Boundary Retaining Wall and Consideration of Potential Changes to Visual Amenity.**

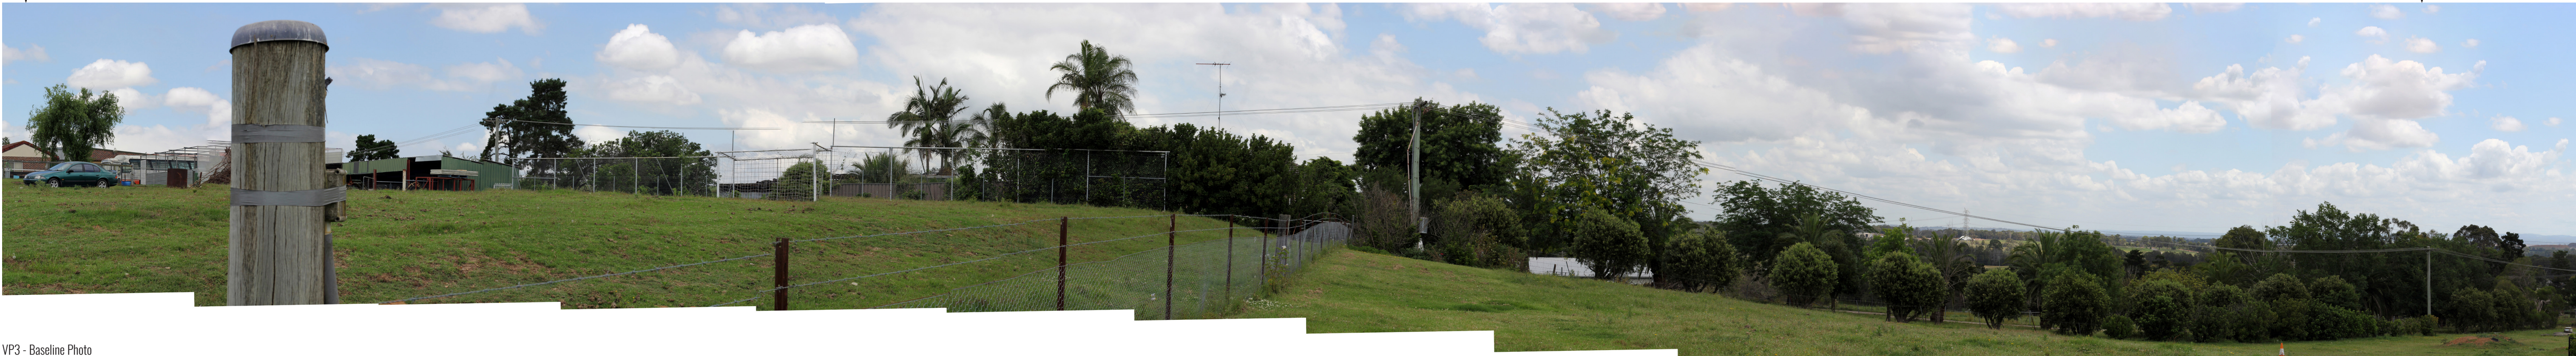
VP3 - Baseline Photo

Geoscapes undertook a Visual Impact Assessment (200723_SSD_RPT_VIA01_REV H) of the original Westlink Stage 1 Scheme (SSD-9138102) which included Viewpoint 3 from 284 Aldington Road. For reference, this viewpoint is attached at the end of this letter. Viewpoint 3 was also representative of potential views from the Heritage listed 'Brick Farmhouse' at 282A which is located imminently east of Viewpoint 3.

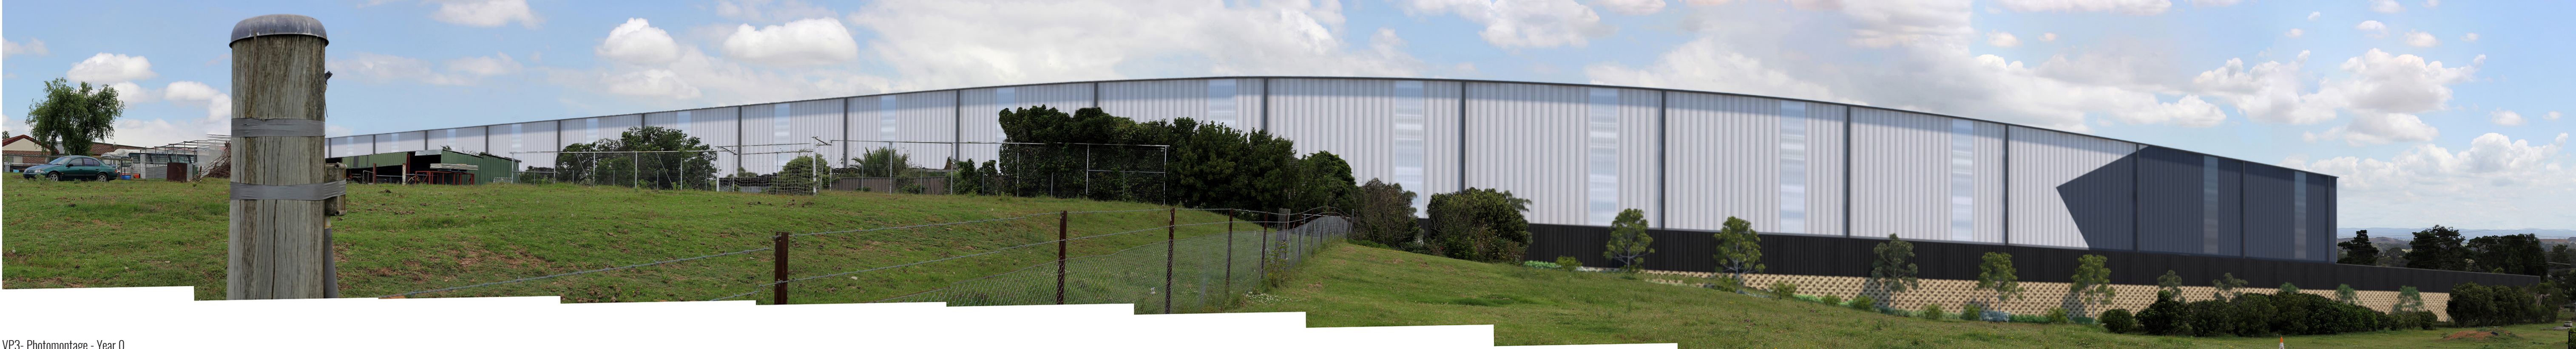
VP3- Photomontage - Year 0

Although the significance of visual impact was assessed to be high due to the close proximity of the development, this was offset by significant landscape planting which would ultimately screen and soften views of the development and the partially exposed retaining wall to the west.

From Viewpoint 3 the proposed MOD4 changes would not result in any change in view (when compared to the 'approved baseline') as the amount of wall seen at this location would remain the same with the same proposed landscaping as represented within the photomontages.
