Acid Sulfate Soil Management Plan

28-30 Burrows Road,
St Peters, NSW

30 September 2022

63126/147434 (Rev 0)

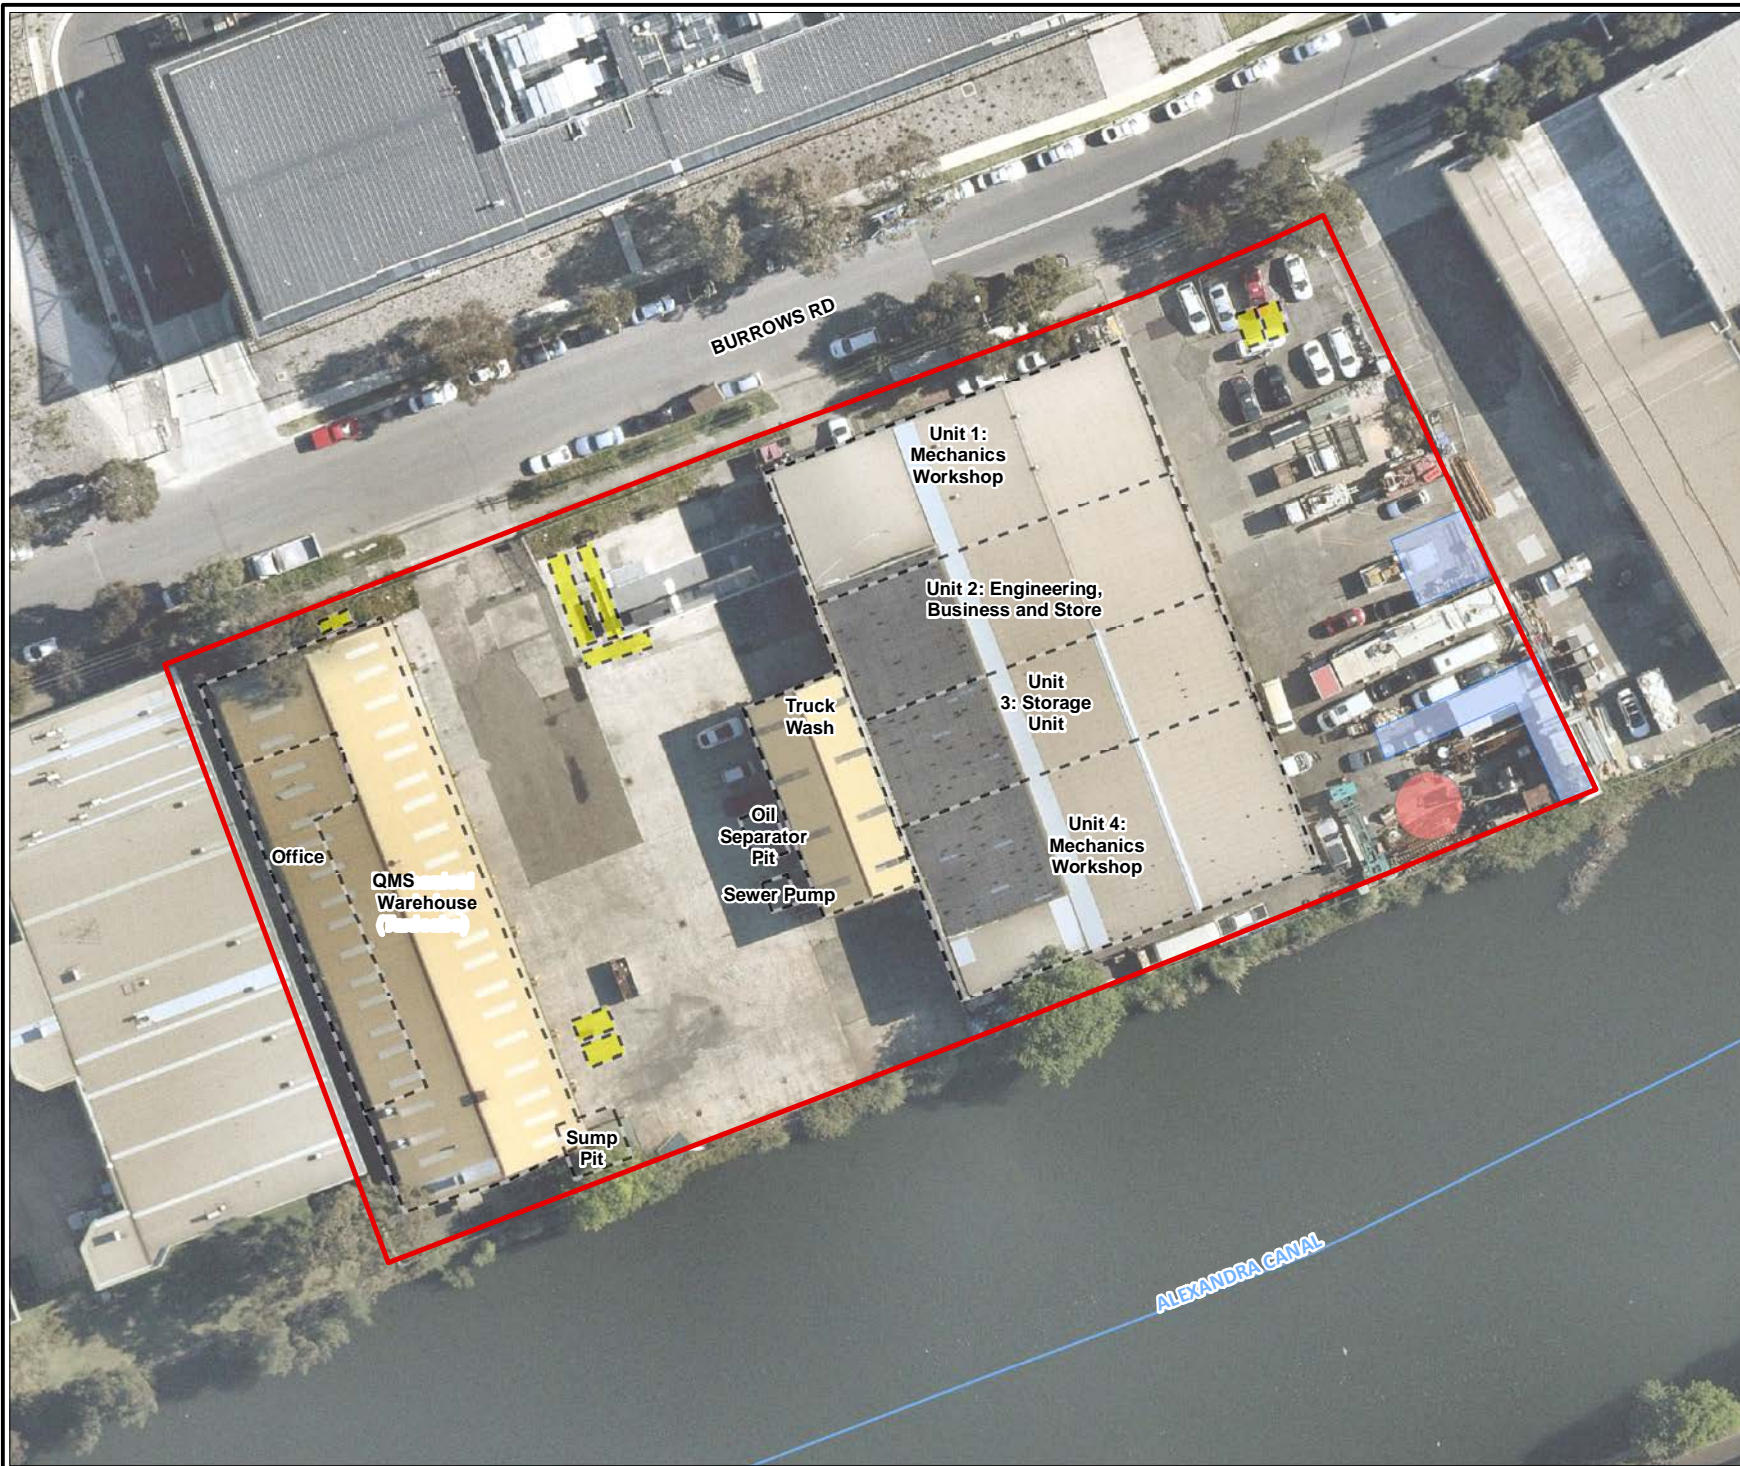
- Legend**
- Approximate Site Boundary
 - Site Features
 - Oil Staining
 - Probable UST
 - Shipping Containers - Storage
 - Site Features

The location and current layout of the site is shown in **Figures 1 and 2** respectively. The site details are summarised in **Table 3.1**.

A sump pit (previously used for waste oil storage) was located in the south-western portion of the property. A sewer pump, oil water separator and pit were located in the south-eastern portion of the property. Fill points and vent pipes present on site indicate the presence of five USTs onsite previously identified by SES (2020⁶) in the northern and southern portions of site. An additional vent pipe was observed in the north-western portion of the site (north of the warehouse) indicating the potential for an additional UST in this area.

30 Burrows Road contained a large warehouse that housed four tenants (two mechanic workshops, engineering business and marine workshop) was situated in the western portion of the property. Units #2 and #4 housed automotive and truck mechanic workshops that contained several car hoists. Evidence of two USTs and the remains of a fuel bowser were observed in the north-eastern portion of the site as reported in SES (2020). The eastern portion of the property was used for storage and as a carpark for vehicles being serviced on the property. Several shipping containers used for storage were present along the south-east boundary.
