NSW Site Auditor Scheme

**Site Audit Statement**

Site audit statement no. 0301-1807

Address	8 and 10 Johnston Crescent		
	HORSLEY Park NSW	Postcode	2175

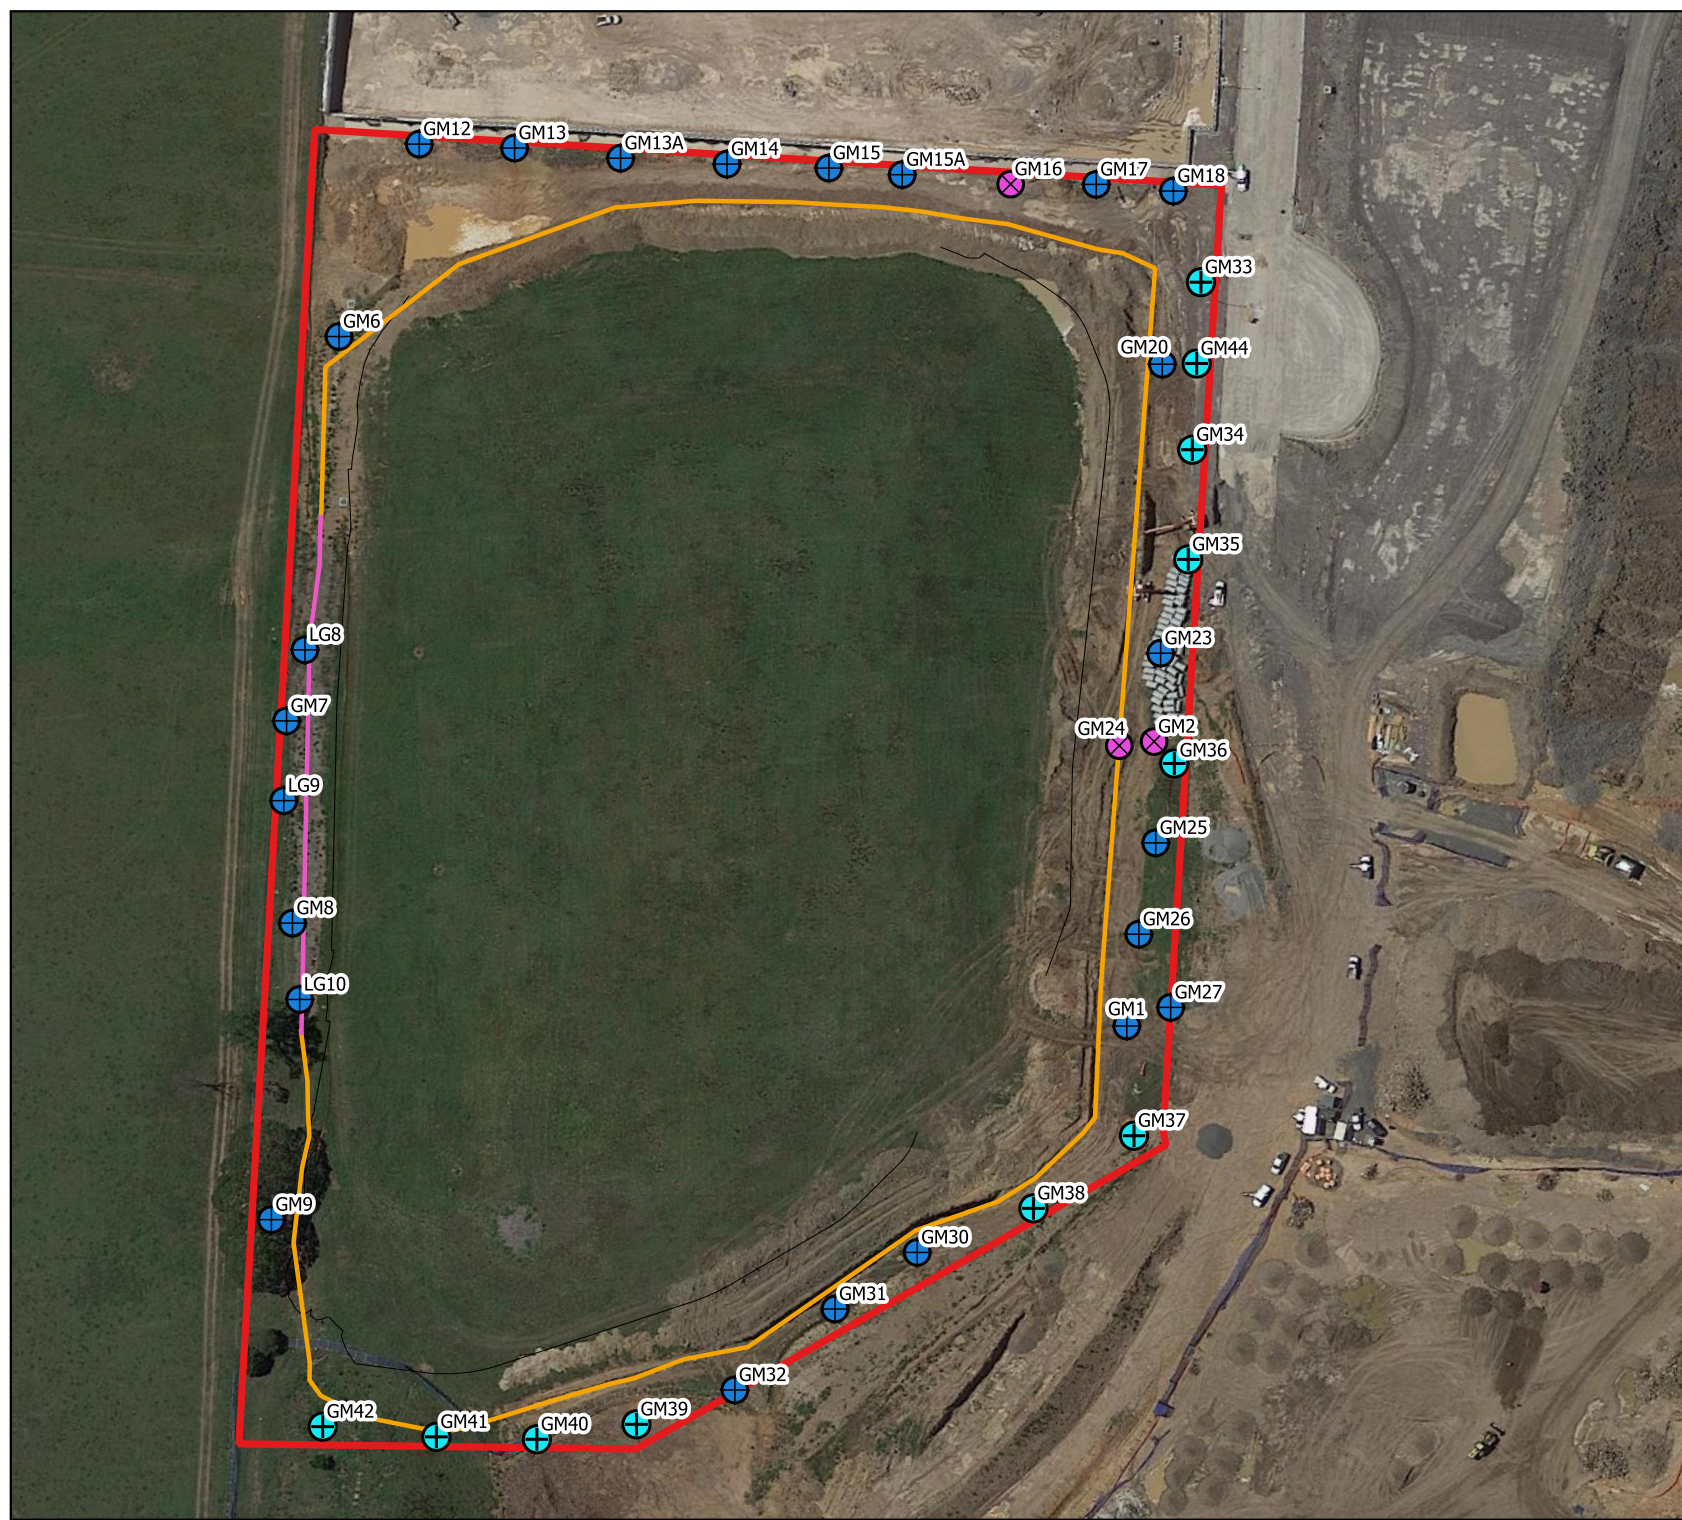
**Figure 2 - LFG Well Locations**

- Site Boundary
- Former Carmide Landfill
- Trench
- Existing Trench
- New Trench
- Monitoring Wells
- ⊕ LFG
- ⊕ New LFG Location
- ⊗ Damaged / Decommissioned

Subsurface monitoring should be undertaken on all landfill gas monitoring wells for the Camide Landfill however the specific wells required to monitor conditions which may impact Stage 2 are outlined in Table 5 below. Monitoring locations are shown on Figure 2. Subsurface monitoring should be undertaken in accordance with NSW EPA *Environmental Guidelines: Solid Waste Landfill* (SWLG 2016).

The condition of each LFG well should be noted on field forms and confirmation as operational or not for the purpose of LFG monitoring. In the event that a monitoring well becomes unsuitable for purpose then the replacement of the monitoring wells should be considered with respect to the overall coverage of the monitoring network.

The suitability of the perimeter monitoring network should be reviewed annually to ensure that the objectives of the EMP are being met. Consideration should be given to replace lost/destroyed wells to ensure the currency of the EMP and adequacy of the perimeter monitoring network to meet the minimum requirements of the intent of this EMP. This should be undertaken during the annual review as outlined in Section 5.

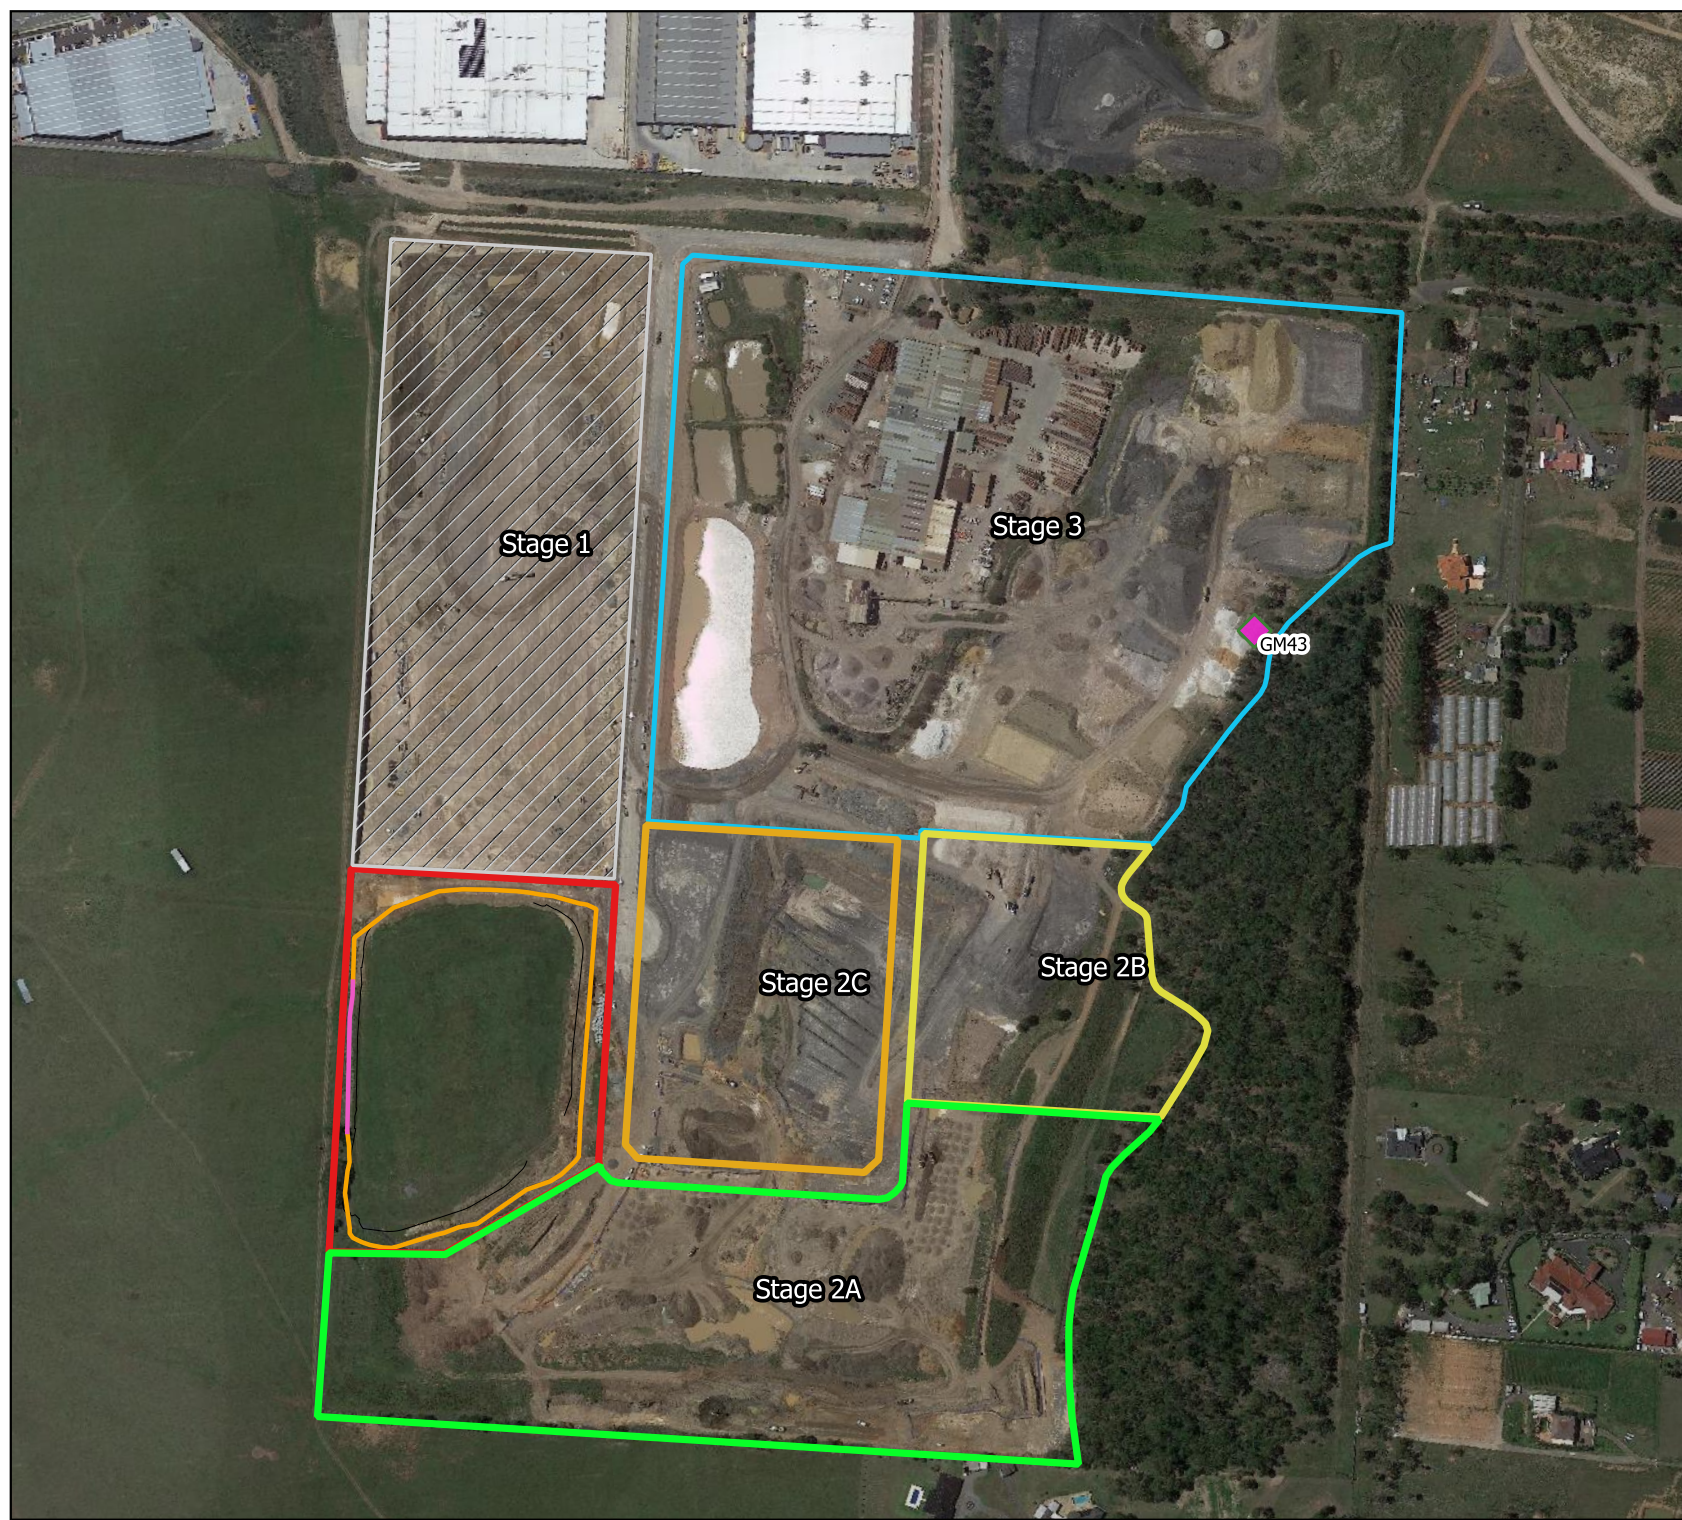
**Figure 4 - Background LFG Well Location**

Note: Survey data has been used where available. Existing biofiltration trench and extent of waste have been replicated from Calibre plans. Existing biofiltration trench constructed in 2005. New biofiltration trench constructed between 2017 and 2019.

During the final installation of the BT some wells were damaged or were in close proximity to the trench which may be influencing the gas concentrations and flow reported during the monthly spot monitoring. As part of the Stage 2 development to the east and south of the landfill ten additional LFG wells and one background LFG location were established to ensure that the perimeter spacing along the eastern and southern boundary of the landfill was approximately 20m. The background LFG location is a sufficient distance from the landfill and is shown on Figure 4.
