Trustee for Huntingwood Property Trust  
Long Term Environmental Management Plan

Proposed Lots 2 and/or 3  
Huntingwood East  
Augusta Street, Blacktown NSW

20 February 2024

62742/146175 (Rev 2)

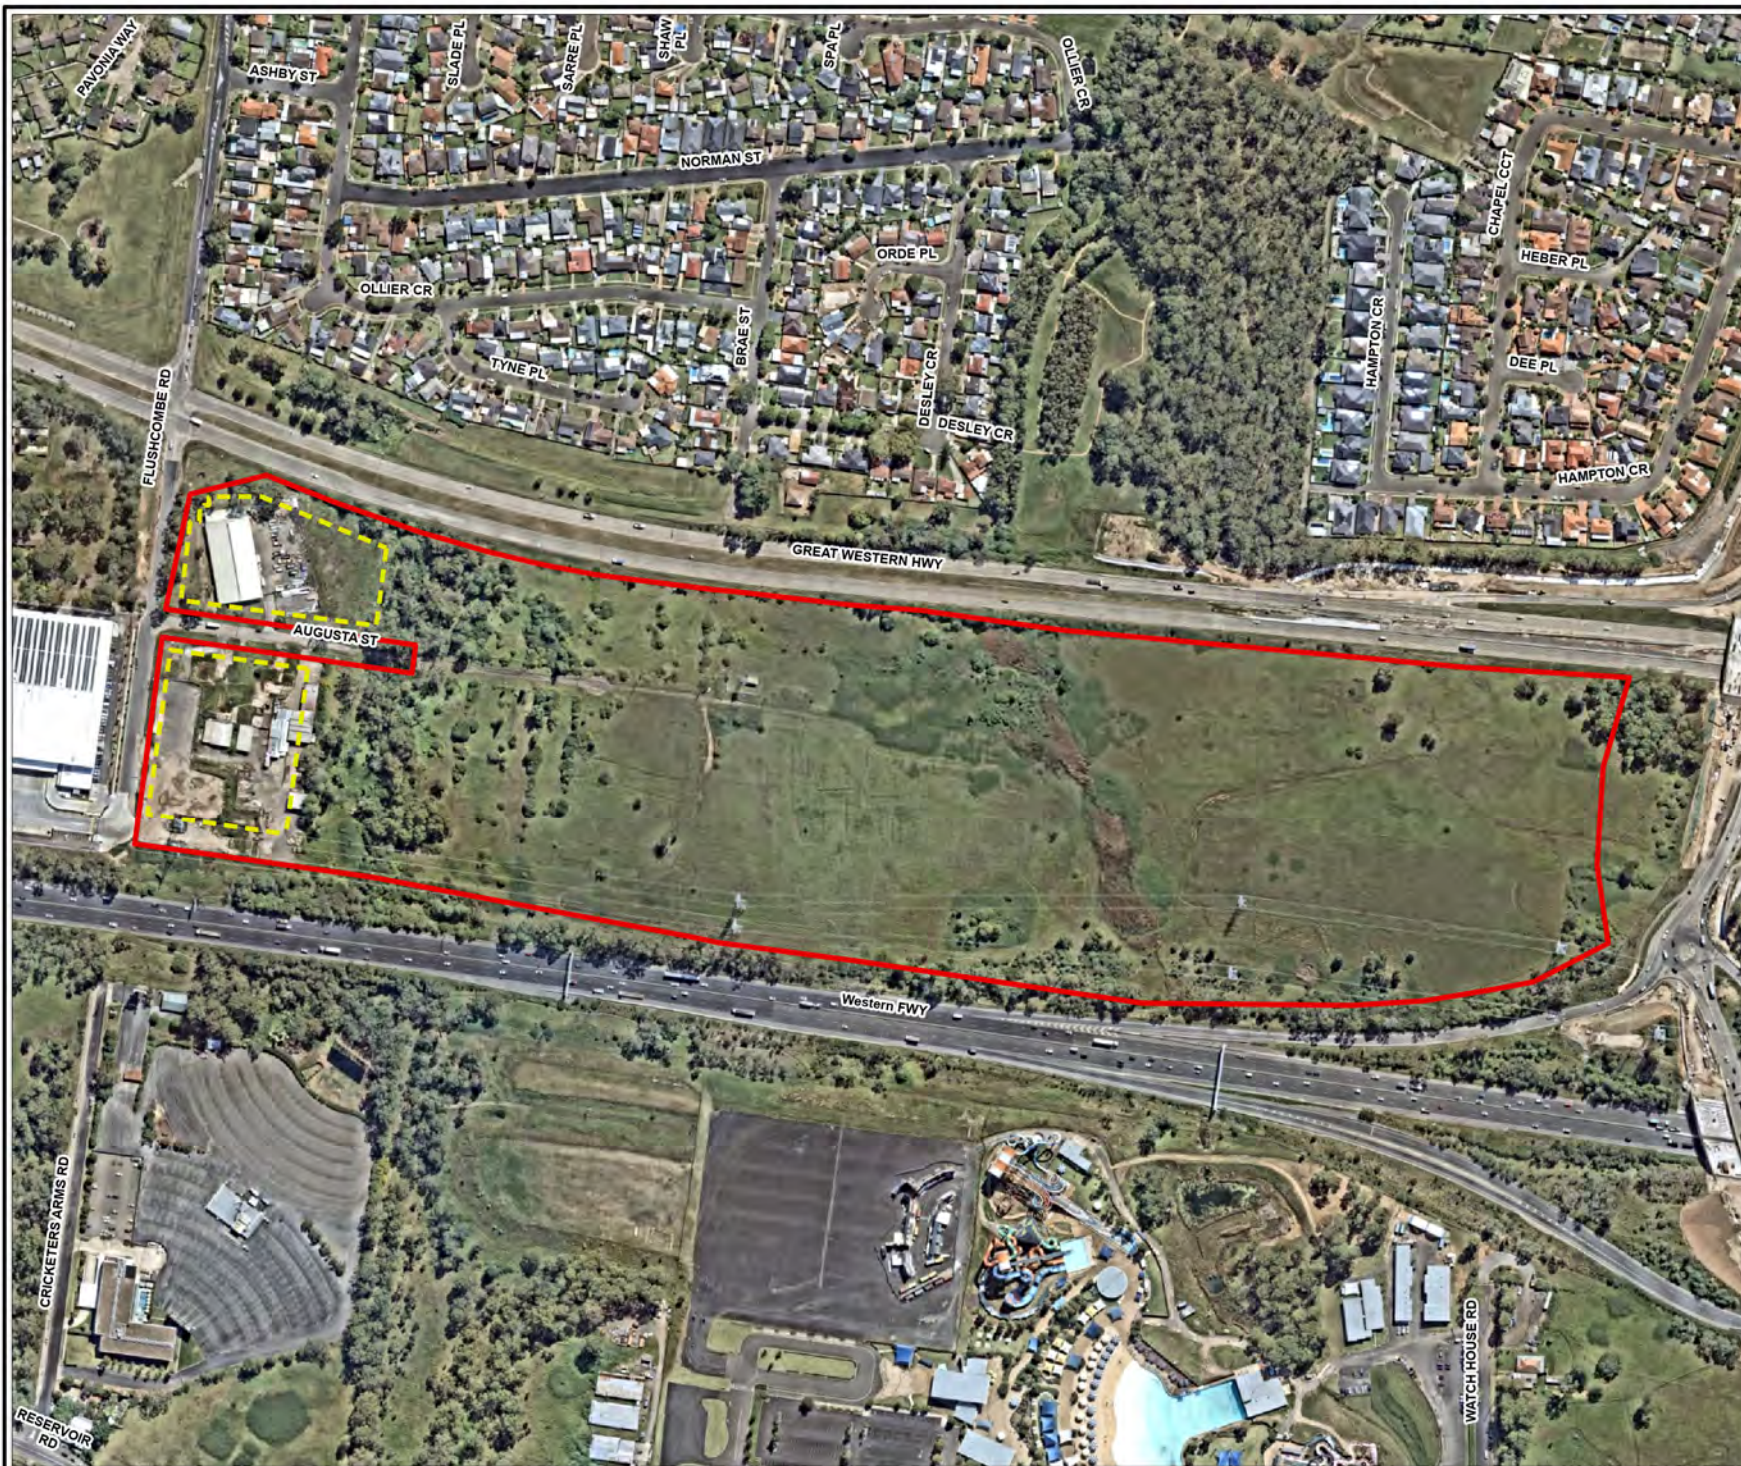
**FIGURE 2**

This LTEMP applies only to the environmentally impacted soils contained within the site (proposed Lots 2 and/or 3), as shown in **Figure 2**, and does not apply to areas with no soil impacts in the greater Huntingwood East Project area. It is not intended to apply to major excavations, earthworks or construction activities. A specific management plan should be prepared in the event that any major works are proposed within the extent of the retained impacted soils.

users, occupiers, visitors and contractors from being potentially exposed to the retained environmentally impacted soils. The proposed extent is shown on **Figure 2**. Photographs of the installation of the capping and marker layer will be provided in **Appendix B** at the completion of the works.

The site location is shown on **Figure 1**. The extent of the site and the project boundaries are shown on **Figure 2**. The site details are summarised in **Table 2.1** and described in detail in the following sections.

Environmentally impacted material as affected with ACM, heavy metals and PAHs will have been retained within the site. The extent of the proposed containment zone is shown on **Figure 2** and defined by surveys provided as **Appendix A**, however, may be subject to change.
