KAWAKAWA BAY LANDSLIP REMEDIATION PERMANENT POST TENSIONED GROUND ANCHORS & DRAINAGE DRILLING

KAWAKAWA BAY, NEW ZEALAND

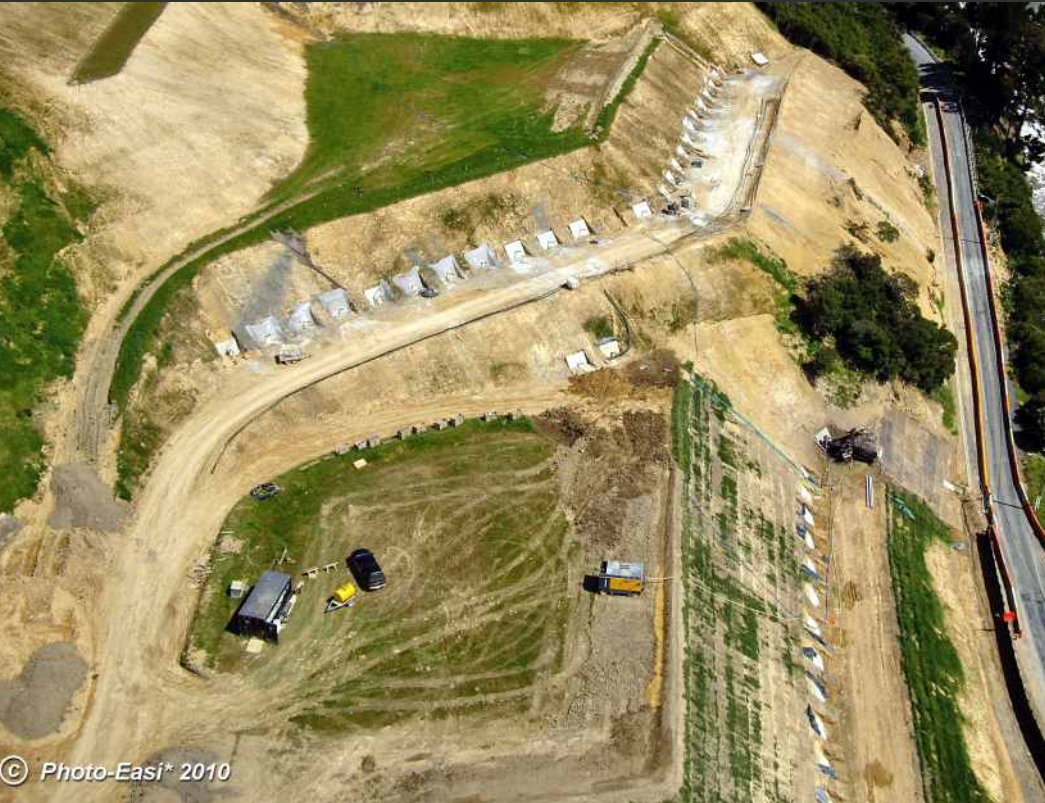
DUPLEX ANCHORS CASED THROUGH 35M OF CLAY AND FRACTURED ROCK

Long term stabilisation works were then completed consisting of benching the slope to enable the duplex cased drilling and installation of 46No. 55m long UTS 4750kN double corrosion protected and anchors with a 100 year design life.
