SEA TECHNOLOGY

Micro-ROV Provides Cost-Effective Way To Inspect Infrastructure

DTG2 ROV Enables Florida Company to Examine Stormwater Pipes

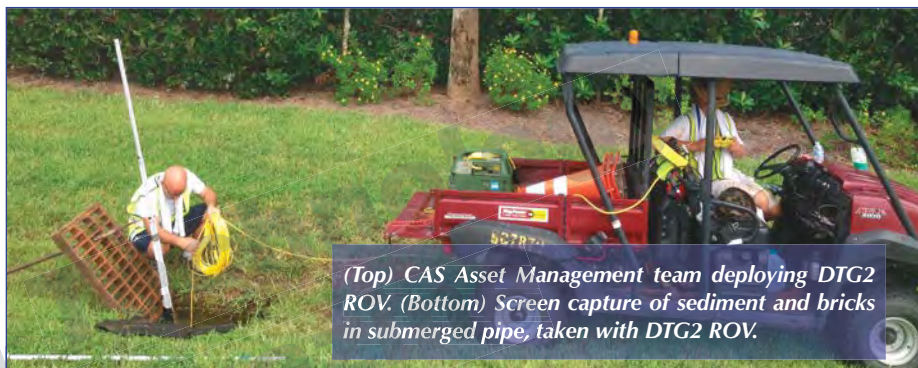
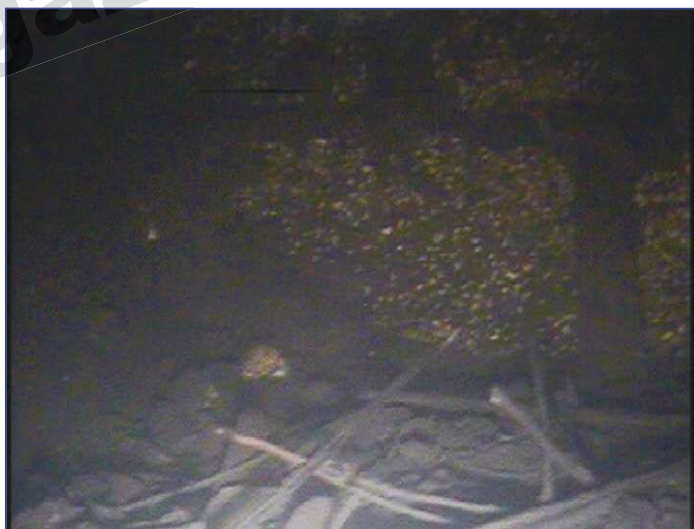
(Top) Deep Trekker DTG2 ROV package.
(Bottom) Deep Trekker DTG2 ROV in action.

With two Deep Trekker (Waterloo, Canada) DTG2 micro-ROVs, depth rated to 250 feet, CAS Asset Management gained the ability to inspect the pipes in an affordable way. The company won the contract to inspect the irrigation system because Riley did the research to find a vehicle that could constantly inspect the system and enable the ability to produce in-depth analysis and plan operations accordingly. With the ROV, they were able to inspect every inch
