Burnaby Refinery CAP Meeting

Table 1: Summary of Project Status, September 13, 2012

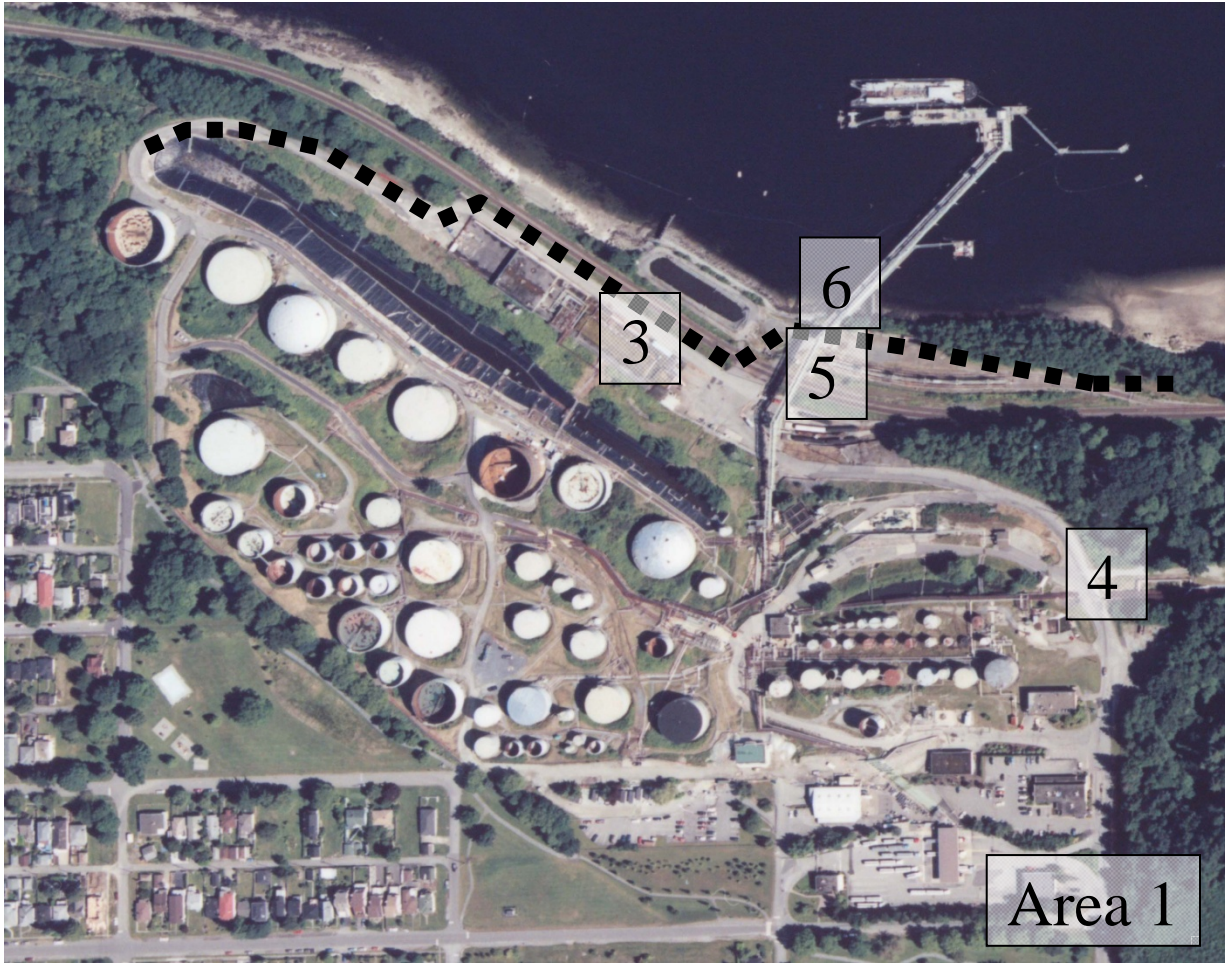
Locations are approximate.

Air photos taken July 2002.

Map No	PROJECT	AREA	CONSULTANT	STATUS
1	Treatment of MTBE in groundwater	2	SLR (Seacor)	No change. (Due to low MTBE concentrations (4 mg/L), treatment to switch from carbon filtration to aeration.)
■ ■ ■ ■	Perimeter Monitoring	1 & 2	URS	Chevron well monitoring program involves semi-annual monitoring. Report of 2011 events provided to BC Environment. 2012 spring and late summer monitoring complete, report in progress.
3	Warehouse	1	URS	No change. (Monitoring, no apparent offsite contamination.)
4	Gardner's Way	1	URS	No change. (Monitoring, no apparent offsite contamination.)
5	Investigation by railroad crossing and Area 3 (G1-4, and Area 3)	1	URS	No change. Area 3 air injection system started in fall 2010.
6	Area 1 Foreshore Sediment Remediation	1	URS	No change. Sheen monitoring program in place.
7	Flare	2	URS	No change. Extraction wells continue to be pumped, minor adjustments and maintenance ongoing.

8	EIB Seep	2	URS	No change. Extraction wells continue to be pumped, adjustments and maintenance ongoing. Foreshore monitored weekly, little to no sheen. Ministry oversight.
9	Ponds	2	URS	Extraction wells continue to be pumped, minor adjustments and maintenance ongoing. Air injection system turned off because water table has been drawn down to below the bottom of the injection wells.
