Burnaby Refinery CAP Meeting

Table 1: Summary of Project Status, June 14, 2011

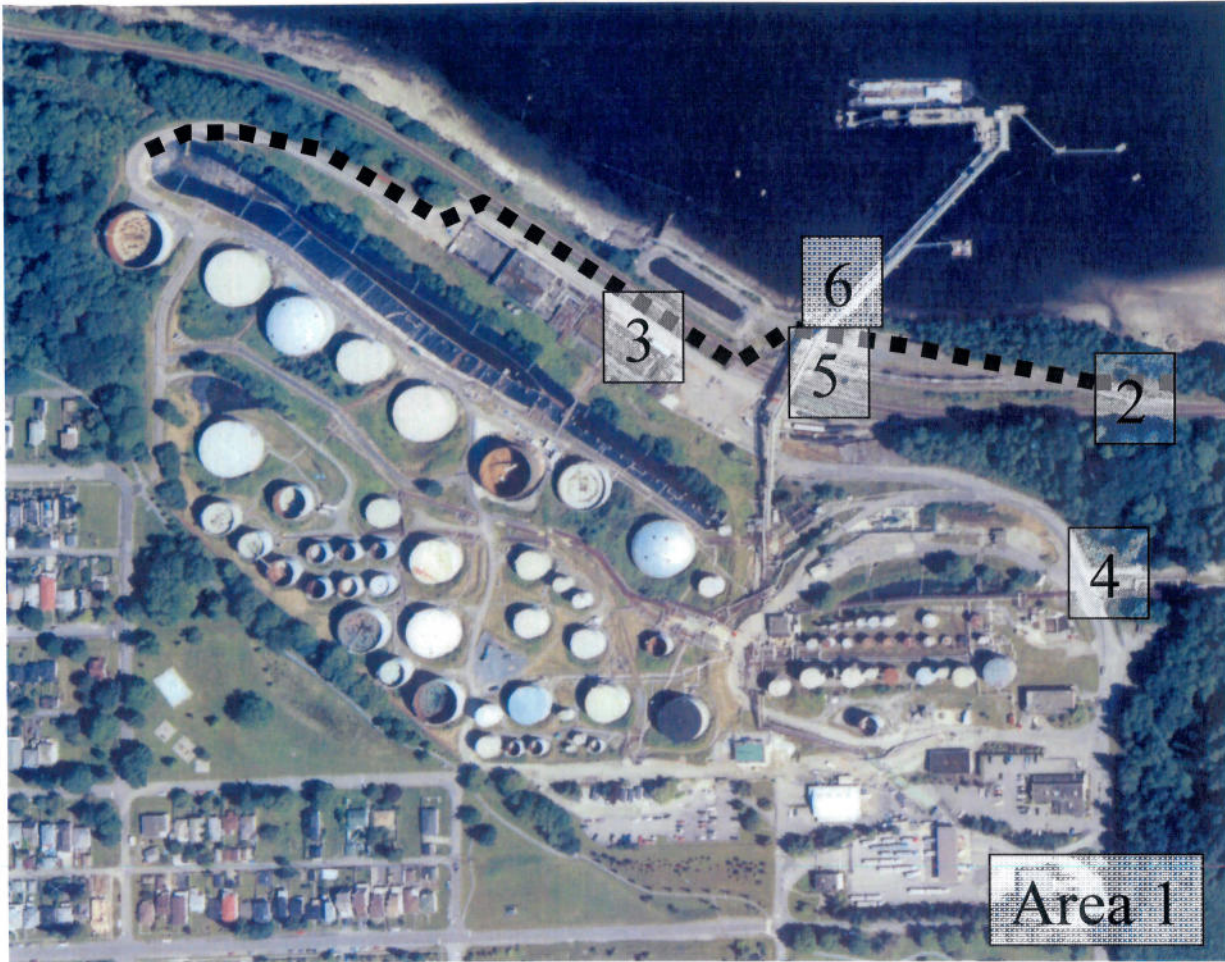
**LEGEND**

1 – MTBE Well A2-9

Line of Perimeter wells  
2 ———

3 – Warehouse

4 – Gardner's Way

5 – Area 3

6 – Area 1 Foreshore

7 - Flare

8 – EIB Seep

9 - Ponds

Locations are approximate.

Air photos taken July 2002.

Map No	PROJECT	AREA	CONSULTANT	STATUS
1	Treatment of MTBE in groundwater	2	SLR (Seacor)	No change. (Due to low MTBE concentrations (4 mg/L), treatment to switch from carbon filtration to aeration.)
2	Perimeter Monitoring	1 & 2	URS	Chevron well monitoring program involves semi-annual monitoring. Report of 2010 events provided to BC Environment. 2011 spring monitoring complete.
3	Warehouse	1	URS	No change. (Monitoring, no apparent offsite contamination.)
4	Gardner's Way	1	URS	No change. (Monitoring, no apparent offsite contamination.)
5	Investigation by railroad crossing and Area 3 (G1-4, and Area 3)	1	URS	Area 3 air injection system started in fall 2010.
6	Area 1 Foreshore Sediment Remediation	1	URS	No change. Remedial excavation report provided Nov 2009, and follow-up risk screening report provided Dec 2009. Sheen monitoring program in place.
7	Flare	2	URS	Adding wells from the EIB Seep to just east of the Flare as an extension of the EIB extraction system.

8	EIB Seep	2	URS	EIB remedial system includes 10 extraction wells in full operation. Extracting ~50L/day of liquid hydrocarbons (as if April 7, 2011). Interception trench installed at railroad. Oleophilic clay boundary at beach. Ministry oversight.
9	Ponds	2	URS	Adding wells from the EIB Seep to just west of the Ponds as an extension of the EIB extraction system. (Pump and treat, and air injection ongoing since 2006 and 2008 respectively)
