SANTA ROSA, FLORIDA

Oyster Lake outfall improvement

CASE STUDY

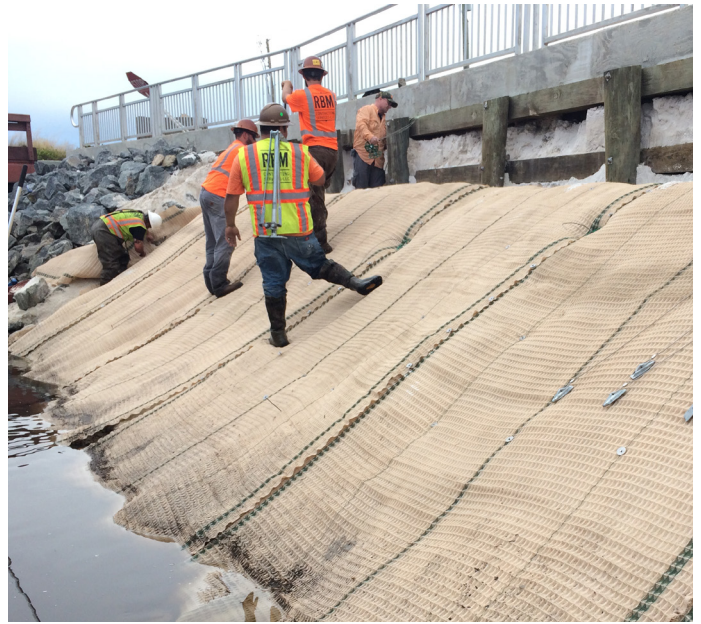
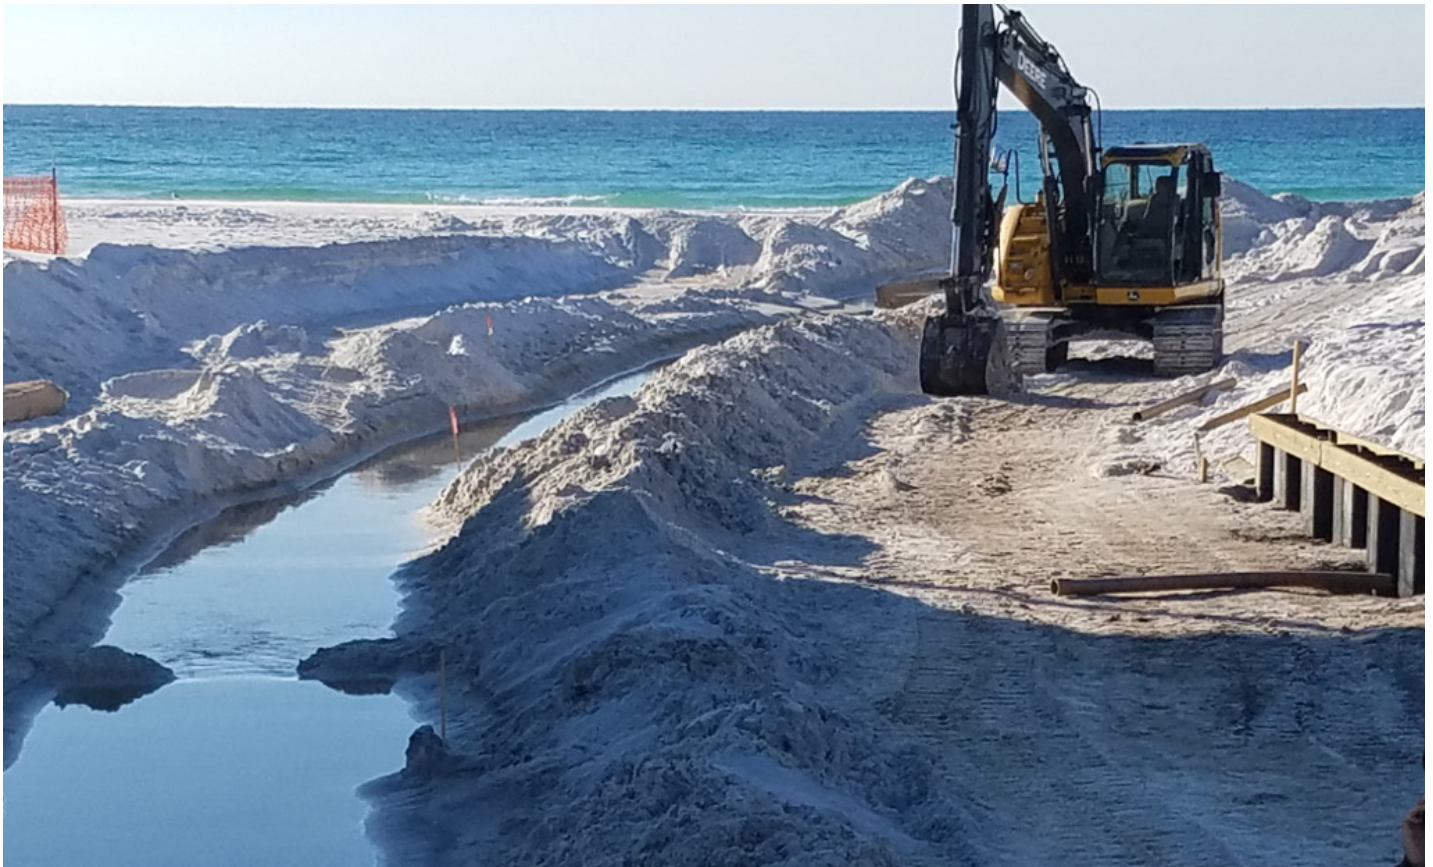
More than 2,000 square yards of **PROPEX Armormax**, consisting of High Performance Turf Reinforcement Mat (HPTRM) and Engineered Earth Anchors (EEA), were installed along the channel. This system was selected because it provides slope stabilization and erosion control while promoting vegetation. During installation, 2,000 sea oats were planted within the HPTRM, which is designed to promote vegetation.

After installation, Hurricane Michael (category 4) made landfall 60 miles east of Oyster Lake causing winds up to 80 mph, storm surge, and significant rainfall and flooding at the project location. The vegetated slopes of the outfall withstood the extreme conditions, protecting beachfront homes, nearby businesses, underground utilities, a section of Highway 30A, and a bridge that crosses the channel.
