DEKALB COUNTY, GEORGIA

Innovative installation of paving fabric for airport pavement rehabilitation

Industry:	Transportation
Application:	Airports
Location:	DeKalb County, Georgia
Product:	Petromat MPV600

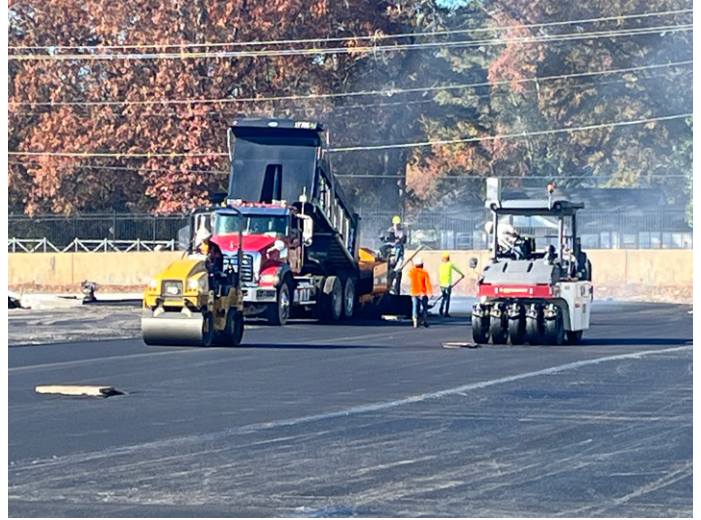
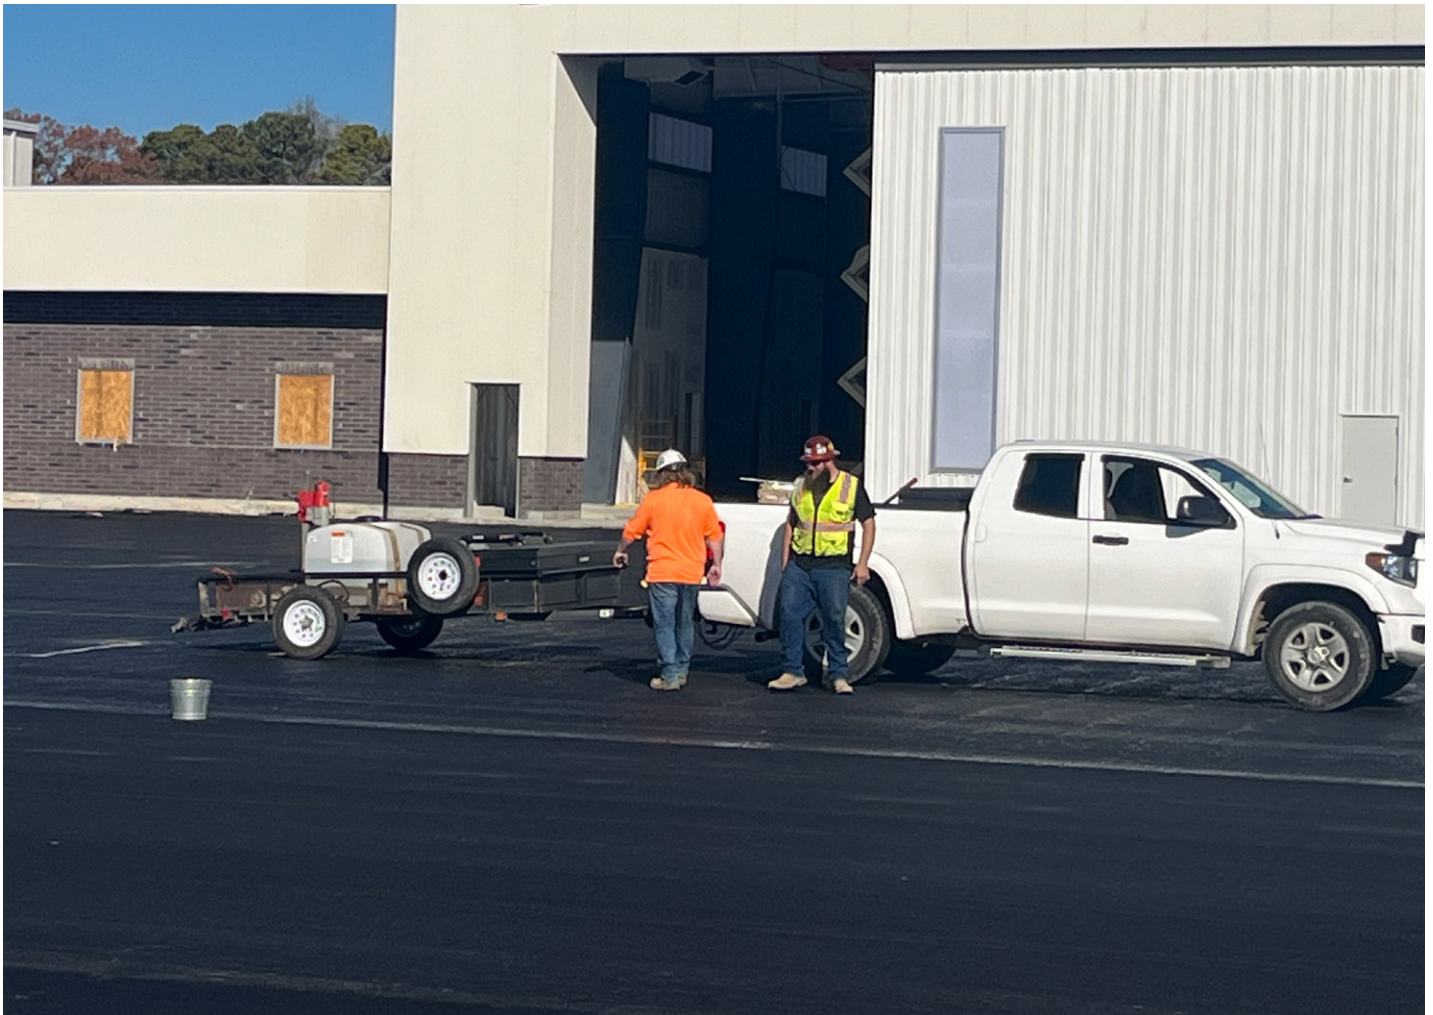
Petromat MPV600 was installed directly on the CTB, providing protection to both overlying layers of the asphalt.

Approximately 11,000 yd² (9,197 m²) of Petromat MPV600 was installed on a section of the airport's pavement. The maximum ambient temperature during installation was 65 degrees Fahrenheit (18 degrees Celsius), and the chosen asphalt binder was a PG64-22. The application rate of the asphalt binder was approximately 0.28 gal/sy (1.37 L/m²). Placing the paving fabric directly on the CTB expedited the installation process and ensured the interlayer could remain in service for future rehabilitations.
