## COASTLINE PROTECTION &amp; EROSION, LAKE MCCONAUGHY, NEBRASKA

# Protecting shorelines from erosion

<b>Industry:</b>	Residential Infrastructure
<b>Application:</b>	Erosion protection
<b>Location:</b>	Lake McConaughy, Ogalla, Nebraska
<b>Product:</b>	<b>GEOTUBE® TC1200MB</b>

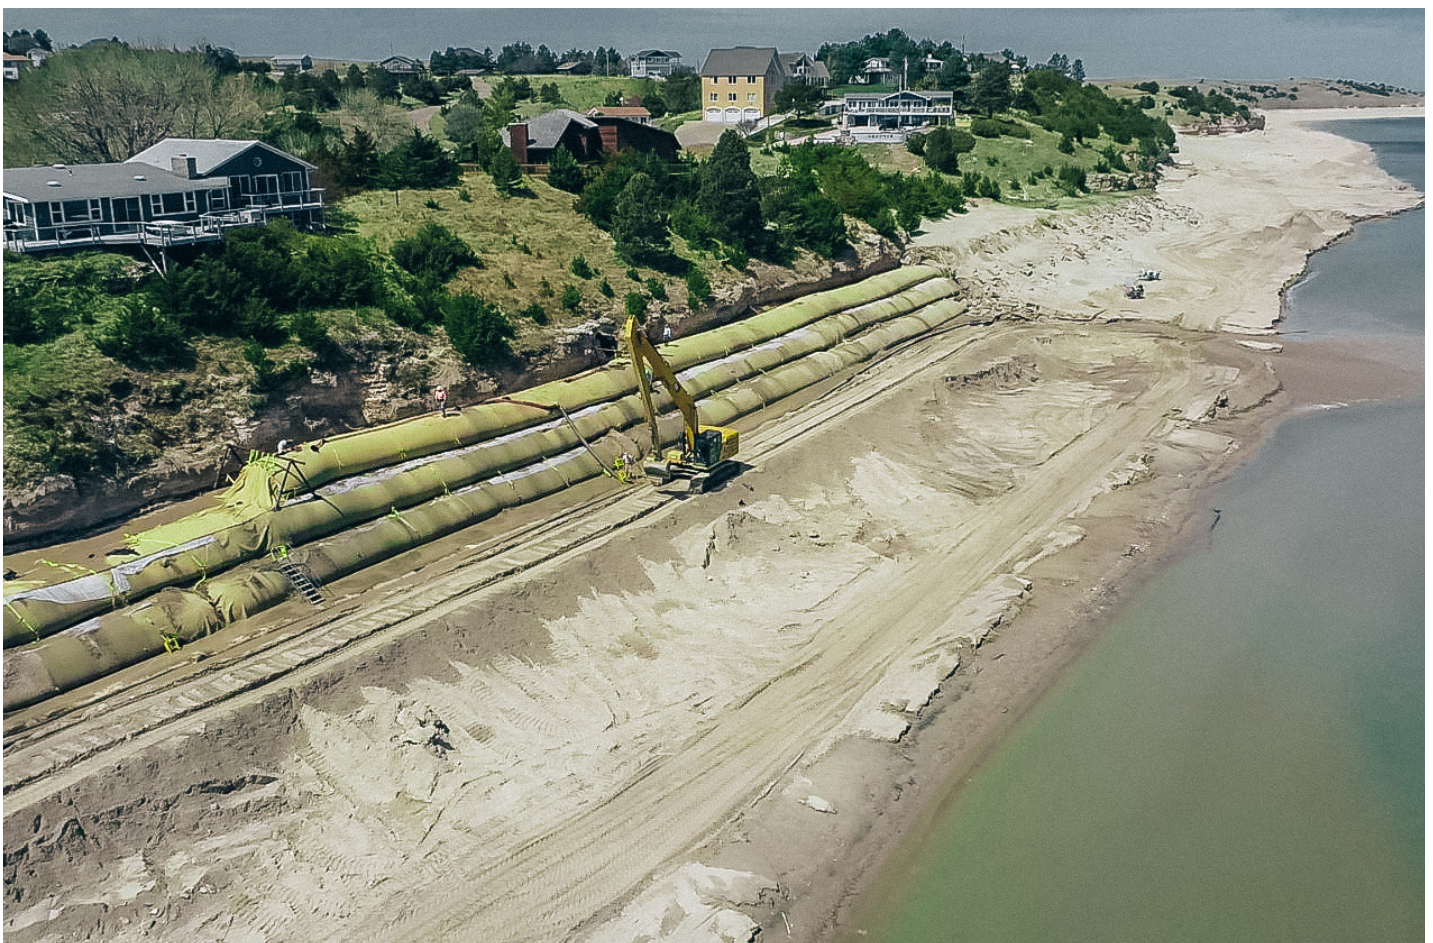
Three layers of 30 ft (9 m) geotextile-tube units were installed to protect 572 ft (174 m) of shoreline. This project successfully stabilized the shoreline along the cliff, protecting at least three homes from collapsing into the lake.

Erosion to the eastern bluff face had caused undercutting that was approximately 16 ft (4.9 m) vertical along the face and 550 ft (168 m) long. To reach the needed height of 16.5 ft, the erosion control structure required three levels of geotextile tubes. Each layer was a minimum of 30 ft (9 m) in circumference and filled with a pumped sand slurry to a

minimum of 5.5 ft (1.7 m) high. The tubes were fabricated with flat ends to achieve a continuous level top surface of each level.
