## HAZOP Template

Zoraya Chemical Mixing Plant / Serrah Engel / 26 Apr 2023

Hazard & Operability Analysis (HAZOP)

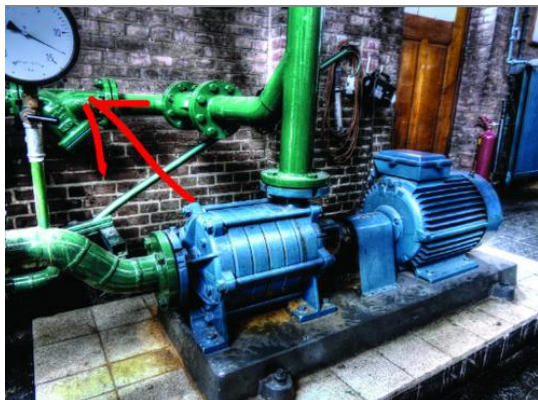
Photo 1

Batch mixer

No RO water flow

Centrifugal pump loses priming or valve closed totally

Resulting in highly concentrated solution

Proper monitoring of the centrifugal pump (hydraulic pressure)

Hydraulic pressure gauge should be reviewed and maintained on a regular basis.

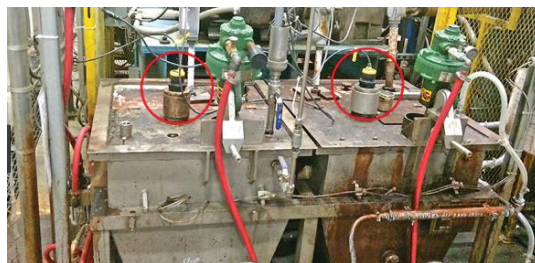
Photo 2

Batch mixer

More RO water flow than intended

Water passes through the valve even if it's closed

Overflow of the batch mixer

Person assigned to monitor batch mixer content

A level indicator needs to be installed for an automatic, accurate reading of the levels.
