Redefining the Standards of Gas Pipeline Inspections

ART Scan™

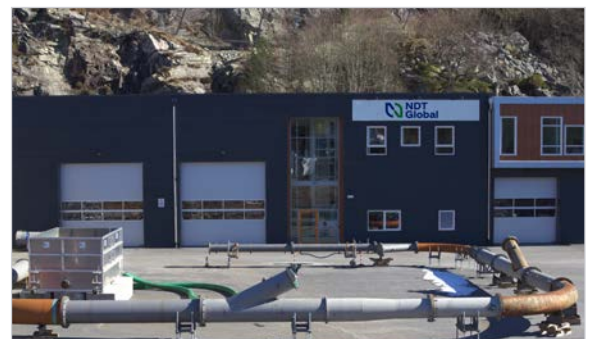
Pump trial setup including diameter change and wye passage.

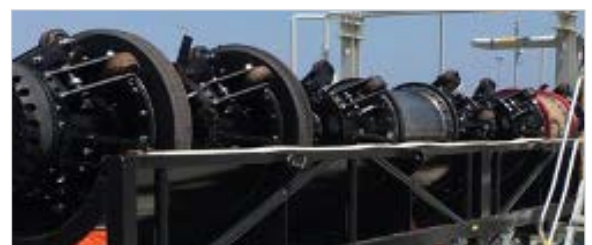
ART Scan tool at receiver after 900 km (~600 miles) inspection.
