Smart Stay Cable Testing Solutions Keep World-famous Bridge Safe

Case Study

The Kao Ping Hsi Stay Cable Bridge crosses the Kao Ping River in southern Taiwan, connecting the Kao Shiung and Ping Tung Counties. A world-famous landmark, it was the longest stay cable bridge in Taiwan and the second-longest single pylon asymmetrical stay cable bridge in the world when it was completed, with a span of 330m.

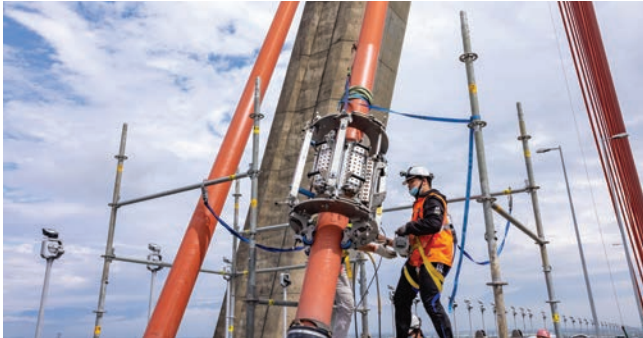
A full detailed cable inspection was performed, using a combination of DYWIDAG manual, visual, and robotic inspections. A manual visual inspection of the anchorages, caps, wedges, and strands was complemented with ultrasonic testing of the anchorage areas. This way, wire fractures, cracks, and corrosion damage could be identified from the ultrasonic readings.
