Overcoming Geotechnical Challenges with Hollow Bars in Brazil

Case Study

The luxury Rhodes Building, located in Piçarras beach, successfully utilized DYWIDAG's DYWI Drill R38-500 for temporary retaining wall anchors, overcoming inherent geotechnical challenges in poor soil conditions. This not only enhanced the stability of the construction but also significantly reduced the project timeline.

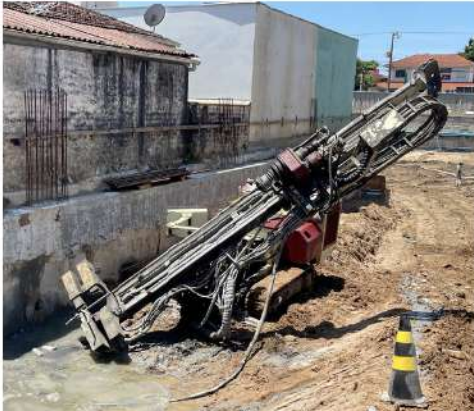
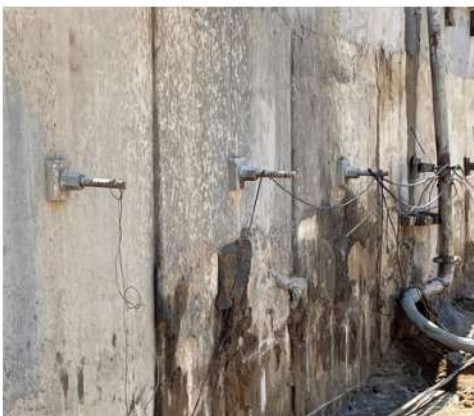
The project team, in conjunction with DYWIDAG, opted to use the DYWI Drill R38-500 system. This innovative solution allows drilling, jetting grout, and installation of the anchors in a single, unified process. The DYWI Drill anchors were used as both drill rod and grout conduit, with installation performed by simultaneous drilling and jetting grout. Consequently, this resolved the prevalent issue of borehole instability, making the project feasible and reducing the timeline significantly. A total of 136 temporary anchors were supplied for the retaining wall of the basement excavation, ensuring a secure foundation for the Rhodes luxury apartment building.
